Access Compliance Report Public Rights-of-Way (Curb Ramps)

Intersection ID: 14364 Main Street: ALBEMARLE_RD Cross Street: DWIGHTWARE_BV Location: SE

ADA ID: FB52281DD7D4 Ramp Type: Perp Initial Pass/Fail: Fail Overall Compliance: No Severity Score: 12.5

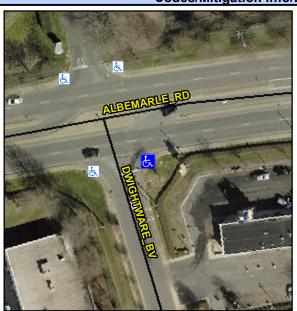
N/A	Ramp Length (in)	59.0	No	Ramp Slope (%)	8.7
Yes	Ramp Width (in)	48.0	Yes	Ramp XSlope (%)	1.6
N/A	Flare Type LT	N/A	N/A	Flare Type RT	N/A
N/A	Flare Slope LT (%)	N/A	N/A	Flare Slope RT (%)	N/A
N/A	Flare Traversable LT?	N/A	N/A	Flare Traversable RT?	N/A
N/A	Landing Length (in)	N/A	N/A N/A DWS Provided?		N/A
N/A	Landing Width (in)	N/A	N/A	DWS Contrast?	N/A
N/A	Landing Slope (%)	N/A	N/A	DWS Length (in)	N/A
N/A	Landing X Slope (%)	N/A	N/A	DWS Full Width?	N/A
N/A	Landing Curb? (Y/N)	N/A	N/A	DWS Offset (in)	N/A
N/A	Shared Landing?	N/A			
N/A	Gutter Ponding?	N/A	N/A	Gutter Slope (%)	N/A
N/A	Gutter Lip Ht (in)	N/A	N/A	Gutter X Slope (%)	N/A
N/A	Painted X Walk1?	No	N/A	Painted X Walk2?	N/A
	X Walk 1 Direction	To W		X Walk 2 Direction	N/A
N/A	X Walk 1 Width (in)	N/A	N/A	X Walk 2 Width (in)	N/A
	X Walk 1 Slope (%)	0.8		X Walk 2 Slope (%)	N/A
	X Walk 1 X Slope (%)	0.8		X Walk 2 X Slope (%)	N/A
N/A	Ramp inside XWalk1?	N/A	N/A	Ramp inside XWalk2?	N/A

Road Slope (%)	N/A	N/A	Clear Space?	N/A
	Road X Slope (%)	N/A	N/A	Clear Space to XWalk (in)	N/A
N/A	Any Obstructions?	N/A	N/A	Storm Grate/Utility Hazard?	N/A
	Obstruction Type		l	Storm Grate/Utility Type	
		N/A			N/A
			Yes	Surface Condition? (G/P)	Good

1 Ossible Solution		i icia ivic	
Possible Solutions:	Comp	liance Description	
Remove & Replace Entire Ramp.	N/A	Ramp Length (in)	
•	Yes	Ramp Width (in)	
	N/A	Flare Type LT	
	N/A	Flare Slope LT (%)	
	N/A	Flare Traversable LT	
	N/A	Landing Length (in)	
Surveyor Notes:	N/A	Landing Width (in)	
N/A	N/A	Landing Slope (%)	
	N/A	Landing X Slope (%)	
	N/A	Landing Curb? (Y/N)	
	N/A	Shared Landing?	
PROW/ADA:	N/A	Gutter Ponding?	
Not Found, R304.2.2	N/A	N/A Gutter Lip Ht (in)	
	N/A	Painted X Walk1?	
		X Walk 1 Direction	
	N/A	X Walk 1 Width (in)	
		X Walk 1 Slope (%)	
		X Walk 1 X Slope (%	
	N/A	Ramp inside XWalk1	
		Road Slope (%)

1850.00
