Access Compliance Report

Public Rights-of-Way

(Curb Ramps)

Intersection ID: 17926	Main Street: N_SHARON_AMITY_RD	Cross Street: RANDOLPH_RD	Location: NE
ADA ID: FB52DDF47983	Ramp Type: PerpDiag	Initial Pass/Fail: Fail	Overall Compliance: No
		Severity Score: 12.5

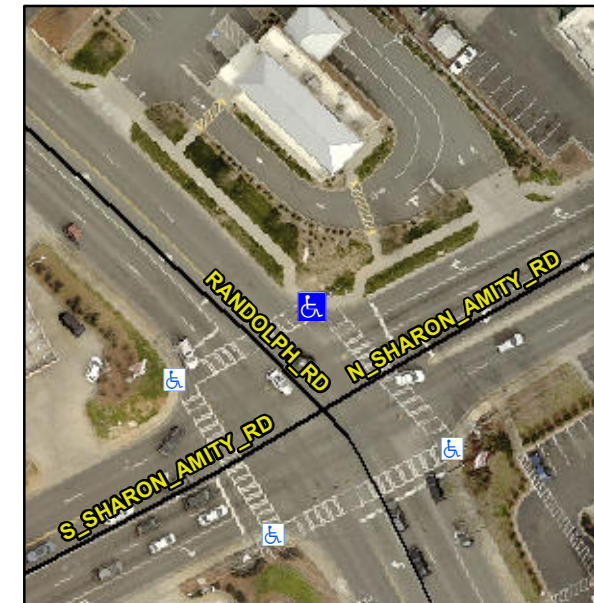
Not Found, R304.2.2

Compliance	Description	Data	Compliance	Description	Data
N/A	Ramp Length (in)	60.0	No	Ramp Slope (%)	9.3
Yes	Ramp Width (in)	48.0	Yes	Ramp XSlope (%)	0.6
N/A	Flare Type LT	N/A	N/A	Flare Type RT	N/A
N/A	Flare Slope LT (%)	N/A	N/A	Flare Slope RT (%)	N/A
N/A	Flare Traversable LT?	N/A	N/A	Flare Traversable RT?	N/A
N/A	Landing Length (in)	N/A	N/A	DWS Provided?	N/A
N/A	Landing Width (in)	N/A	N/A	DWS Contrast?	N/A
N/A	Landing Slope (%)	N/A	N/A	DWS Length (in)	N/A
N/A	Landing X Slope (%)	N/A	N/A	DWS Full Width?	N/A
N/A	Landing Curb? (Y/N)	N/A	N/A	DWS Offset (in)	N/A
N/A	Shared Landing?	N/A			
N/A	Gutter Ponding?	N/A	N/A	Gutter Slope (%)	N/A
N/A	Gutter Lip Ht (in)	N/A	N/A	Gutter X Slope (%)	N/A
N/A	Painted X Walk1?	Yes	N/A	Painted X Walk2?	Yes
	X Walk 1 Direction	To W		X Walk 2 Direction	To S
N/A	X Walk 1 Width (in)	110.0	N/A	X Walk 2 Width (in)	107.0
	X Walk 1 Slope (%)	2.2		X Walk 2 Slope (%)	0.7
	X Walk 1 X Slope (%)	2.3		X Walk 2 X Slope (%)	0.0

N/A	Ramp inside XWalk1?	Yes	N/A	Ramp inside XWalk2?	Yes
	Road Slope (%)	0.3	N/A	Clear Space?	N/A
	Road X Slope (%)	1.1	N/A	Clear Space to XWalk (in)	N/A
N/A	Any Obstructions?	N/A	N/A	Storm Grate/Utility Hazard?	N/A
	Obstruction Type			Storm Grate/Utility Type	
		N/A			N/A
		Yes		Surface Condition? (G/P)	Good

Possible Solutions:

Remove & Replace Curb Ramp With Two New Directional Ramps or Equivalent.

Total Cost: \$ 3200.00
