Access Compliance Report

Public Rights-of-Way

(Curb Ramps)

Intersection ID: 13277	Main Street: SPRUCE_ST	Cross Street: WILMORE_DR	Location: SW
ADA ID: FB5C4E4154B2	Ramp Type: PerpDiag	Initial Pass/Fail: Fail	Overall Compliance: No
Severity Score: 13.75			
Codes/Mitigation Info/Possible Solution		Field Measurements/Component Compliance

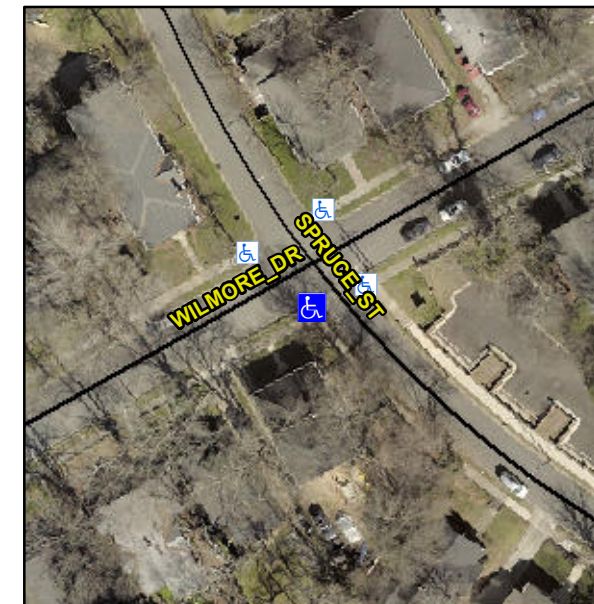
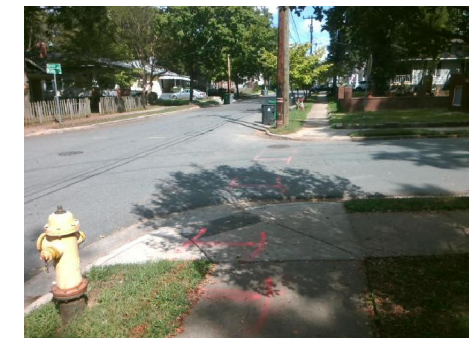
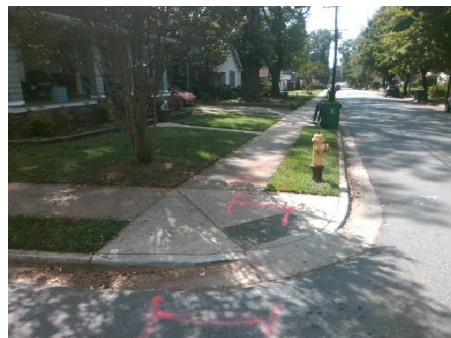
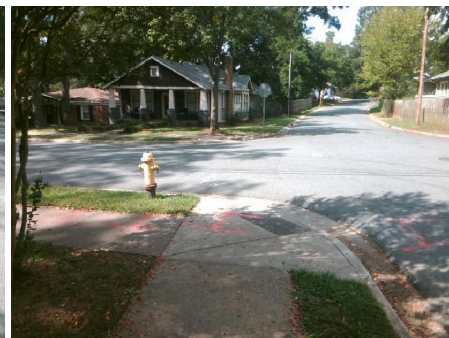
Not Found, R304.2.2, R304.5.3

Compliance	Description	Data	Compliance	Description	Data
N/A	Ramp Length (in)	60.0	No	Ramp Slope (%)	8.6
Yes	Ramp Width (in)	48.0	No	Ramp XSlope (%)	2.3
N/A	Flare Type LT	N/A	N/A	Flare Type RT	N/A
N/A	Flare Slope LT (%)	N/A	N/A	Flare Slope RT (%)	N/A
N/A	Flare Traversable LT?	N/A	N/A	Flare Traversable RT?	N/A
N/A	Landing Length (in)	N/A	N/A	DWS Provided?	N/A
N/A	Landing Width (in)	N/A	N/A	DWS Contrast?	N/A
N/A	Landing Slope (%)	N/A	N/A	DWS Length (in)	N/A
N/A	Landing X Slope (%)	N/A	N/A	DWS Full Width?	N/A
N/A	Landing Curb? (Y/N)	N/A	N/A	DWS Offset (in)	N/A
N/A	Shared Landing?	N/A			
N/A	Gutter Ponding?	N/A	N/A	Gutter Slope (%)	N/A
N/A	Gutter Lip Ht (in)	N/A	N/A	Gutter X Slope (%)	N/A
N/A	Painted X Walk1?	No	N/A	Painted X Walk2?	No
	X Walk 1 Direction	To NE		X Walk 2 Direction	To NW
N/A	X Walk 1 Width (in)	N/A	N/A	X Walk 2 Width (in)	N/A
	X Walk 1 Slope (%)	6.8		X Walk 2 Slope (%)	5.1
	X Walk 1 X Slope (%)	0.3		X Walk 2 X Slope (%)	5.4

N/A	Ramp inside XWalk1?	N/A	N/A	Ramp inside XWalk2?	N/A
	Road Slope (%)	1.4	N/A	Clear Space?	N/A
	Road X Slope (%)	5.1	N/A	Clear Space to XWalk (in)	N/A
N/A	Any Obstructions?	N/A	N/A	Storm Grate/Utility Hazard?	N/A
	Obstruction Type			Storm Grate/Utility Type	
		N/A			N/A
		Yes		Surface Condition? (G/P)	Good

Possible Solutions:

Remove & Replace Curb Ramp With Two New Directional Ramps or Equivalent.
