# Access Compliance Report

## Public Rights-of-Way

### (Curb Ramps)

Intersection ID: 14266	Main Street: BRIAR_CREEK_RD	Cross Street: CREIGHTON_DR	Location: S
ADA ID: FB5D3206FCFE	Ramp Type: Perp	Initial Pass/Fail: Fail	Overall Compliance: No
Severity Score: 33.75			
Codes/Mitigation Info/Possible Solution		Field Measurements/Component Compliance

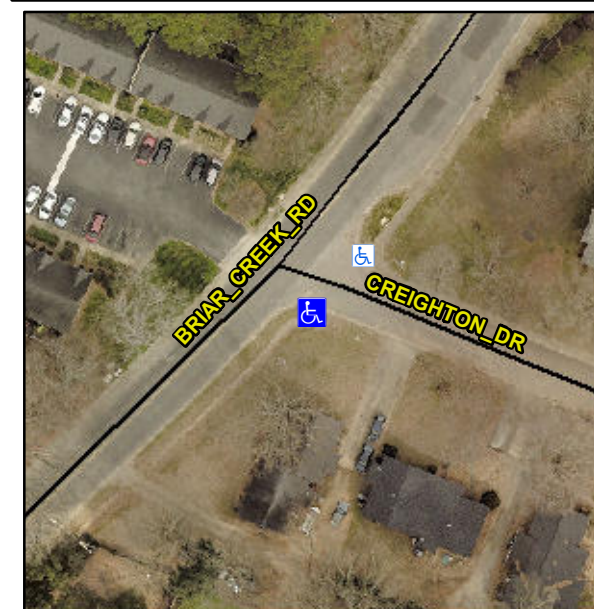
**Not Found, R304.5.1, R304.5.3**

Compliance	Description	Data	Compliance	Description	Data
N/A	Ramp Length (in)	48.0	Yes	Ramp Slope (%)	5.5
No	Ramp Width (in)	44.0	No	Ramp XSlope (%)	7.3
N/A	Flare Type LT	N/A	N/A	Flare Type RT	N/A
N/A	Flare Slope LT (%)	N/A	N/A	Flare Slope RT (%)	N/A
N/A	Flare Traversable LT?	N/A	N/A	Flare Traversable RT?	N/A
N/A	Landing Length (in)	N/A	N/A	DWS Provided?	N/A
N/A	Landing Width (in)	N/A	N/A	DWS Contrast?	N/A
N/A	Landing Slope (%)	N/A	N/A	DWS Length (in)	N/A
N/A	Landing X Slope (%)	N/A	N/A	DWS Full Width?	N/A
N/A	Landing Curb? (Y/N)	N/A	N/A	DWS Offset (in)	N/A
N/A	Shared Landing?	N/A			
N/A	Gutter Ponding?	N/A	N/A	Gutter Slope (%)	N/A
N/A	Gutter Lip Ht (in)	N/A	N/A	Gutter X Slope (%)	N/A
N/A	Painted X Walk1?	No	N/A	Painted X Walk2?	N/A
	X Walk 1 Direction	To NE		X Walk 2 Direction	N/A
N/A	X Walk 1 Width (in)	N/A	N/A	X Walk 2 Width (in)	N/A
	X Walk 1 Slope (%)	1.3		X Walk 2 Slope (%)	N/A
	X Walk 1 X Slope (%)	5.8		X Walk 2 X Slope (%)	N/A

N/A	Ramp inside XWalk1?	N/A	N/A	Ramp inside XWalk2?	N/A
	Road Slope (%)	N/A	N/A	Clear Space?	N/A
	Road X Slope (%)	N/A	N/A	Clear Space to XWalk (in)	N/A
N/A	Any Obstructions?	N/A	N/A	Storm Grate/Utility Hazard?	N/A
	Obstruction Type			Storm Grate/Utility Type	
		N/A			N/A
		Yes		Surface Condition? (G/P)	Good

**Remove & Replace Entire Ramp.**

Total Cost: \$ 1850.00
