Intersection ID: 26940	Main Street: ESHERWOOD_LN	Cross Street: WYNYATES_LN	Location:	N
ADA ID: FB601DD96AD5	Ramp Type: Perp	Initial Pass/Fail: Fail	Overall Compliance: No	Severity Score: 8.75

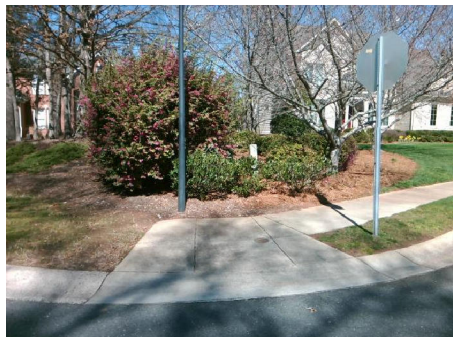
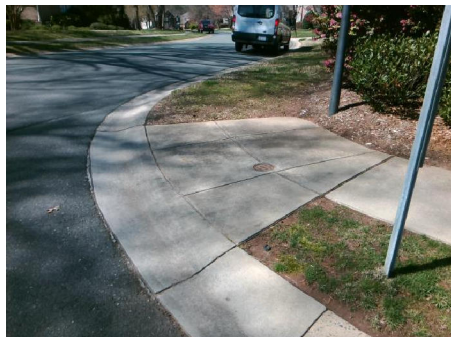
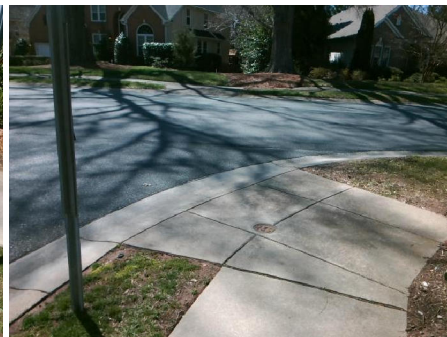
**Not Found, R304.5.1**

Possible Solutions:			Compliance	Description	Data	Compliance	Description	Data
<b>Remove &amp; Replace Entire Ramp.</b>			N/A	Ramp Length (in)	36.5	Yes	Ramp Slope (%)	7.1
			No	Ramp Width (in)	42.5	Yes	Ramp XSlope (%)	0.3
			N/A	Flare Type LT	N/A	N/A	Flare Type RT	N/A
			N/A	Flare Slope LT (%)	N/A	N/A	Flare Slope RT (%)	N/A
			N/A	Flare Traversable LT?	N/A	N/A	Flare Traversable RT?	N/A
			N/A	Landing Length (in)	N/A	N/A	DWS Provided?	N/A
			N/A	Landing Width (in)	N/A	N/A	DWS Contrast?	N/A
			N/A	Landing Slope (%)	N/A	N/A	DWS Length (in)	N/A
			N/A	Landing X Slope (%)	N/A	N/A	DWS Full Width?	N/A
			N/A	Landing Curb? (Y/N)	N/A	N/A	DWS Offset (in)	N/A
			N/A	Shared Landing?	N/A			
			N/A	Gutter Ponding?	N/A	N/A	Gutter Slope (%)	N/A
			N/A	Gutter Lip Ht (in)	N/A	N/A	Gutter X Slope (%)	N/A
			N/A	Painted X Walk1?	No	N/A	Painted X Walk2?	N/A
				X Walk 1 Direction	To SW		X Walk 2 Direction	N/A
N/A	X Walk 1 Width (in)	N/A	N/A	X Walk 2 Width (in)	N/A

X Walk 1 Slope (%)	3.5		X Walk 2 Slope (%)	N/A			
	X Walk 1 X Slope (%)	0.0		X Walk 2 X Slope (%)	N/A			
N/A	Ramp inside XWalk1?	N/A	N/A	Ramp inside XWalk2?	N/A			
	Road Slope (%)	N/A	N/A	Clear Space?	N/A			
	Road X Slope (%)	N/A	N/A	Clear Space to XWalk (in)	N/A			
N/A	Any Obstructions?	N/A	N/A	Storm Grate/Utility Hazard?	N/A			
Total Cost:	\$	1850.00		Obstruction Type		Storm Grate/Utility Type		
					N/A			N/A
						Yes	Surface Condition? (G/P)	Good

### Remove & Replace Entire Ramp.

Total Cost: \$ 1850.00
