Access Compliance Report

Public Rights-of-Way

(Curb Ramps)

Intersection ID: N/A	Main Street: BEREWICK COMMONS PKY	Cross Street: STONEWELLS DR	Location: S
ADA ID: FB6039984D0A	Ramp Type: PerpDiag	Initial Pass/Fail: Fail	Overall Compliance: No
		Severity Score: 12.5

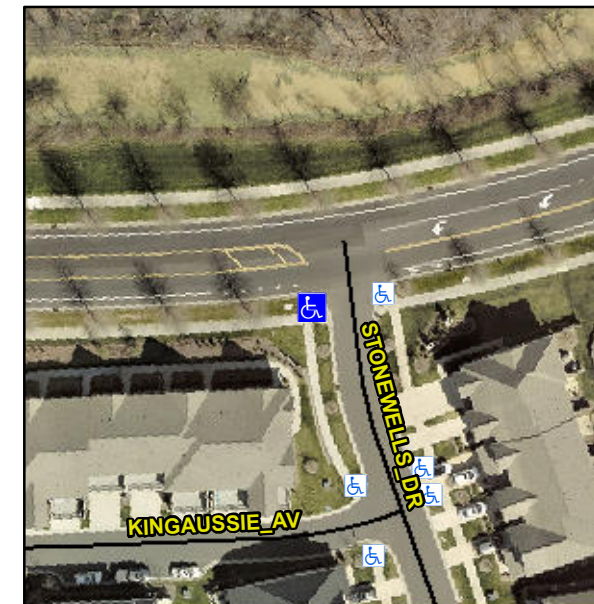
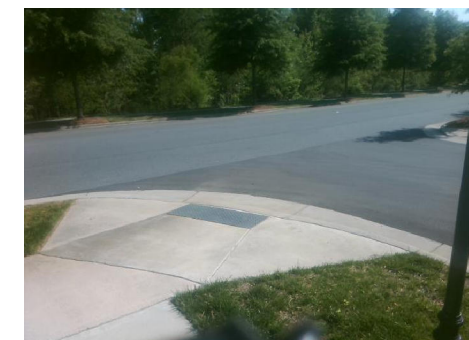
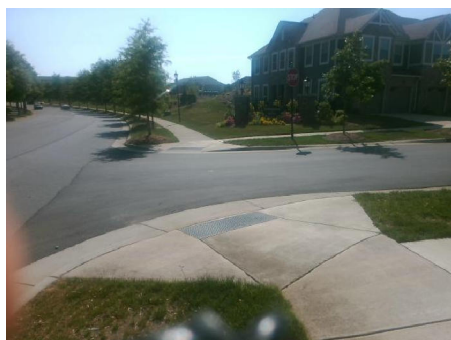
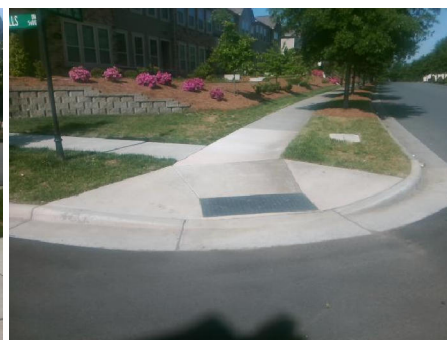
Not Found, R304.2.2

Compliance	Description	Data	Compliance	Description	Data
N/A	Ramp Length (in)	90.0	No	Ramp Slope (%)	9.2
Yes	Ramp Width (in)	60.0	Yes	Ramp XSlope (%)	1.9
N/A	Flare Type LT	N/A	N/A	Flare Type RT	N/A
N/A	Flare Slope LT (%)	N/A	N/A	Flare Slope RT (%)	N/A
N/A	Flare Traversable LT?	N/A	N/A	Flare Traversable RT?	N/A
N/A	Landing Length (in)	N/A	N/A	DWS Provided?	N/A
N/A	Landing Width (in)	N/A	N/A	DWS Contrast?	N/A
N/A	Landing Slope (%)	N/A	N/A	DWS Length (in)	N/A
N/A	Landing X Slope (%)	N/A	N/A	DWS Full Width?	N/A
N/A	Landing Curb? (Y/N)	N/A	N/A	DWS Offset (in)	N/A
N/A	Shared Landing?	N/A			
N/A	Gutter Ponding?	N/A	N/A	Gutter Slope (%)	N/A
N/A	Gutter Lip Ht (in)	N/A	N/A	Gutter X Slope (%)	N/A
N/A	Painted X Walk1?	No	N/A	Painted X Walk2?	No
	X Walk 1 Direction	To E		X Walk 2 Direction	To N
N/A	X Walk 1 Width (in)	N/A	N/A	X Walk 2 Width (in)	N/A
	X Walk 1 Slope (%)	0.2		X Walk 2 Slope (%)	2.0
	X Walk 1 X Slope (%)	0.1		X Walk 2 X Slope (%)	1.2

N/A	Ramp inside XWalk1?	N/A	N/A	Ramp inside XWalk2?	N/A
	Road Slope (%)	0.1	N/A	Clear Space?	N/A
	Road X Slope (%)	0.6	N/A	Clear Space to XWalk (in)	N/A
N/A	Any Obstructions?	N/A	N/A	Storm Grate/Utility Hazard?	N/A
	Obstruction Type			Storm Grate/Utility Type	
		N/A			N/A
			Yes	Surface Condition? (G/P)	Good

Remove & Replace Curb Ramp With Two New Directional Ramps or Equivalent.
