# Access Compliance Report

## Public Rights-of-Way

### (Curb Ramps)

Intersection ID: 14061	Main Street: BARCLIFF_DR	Cross Street: LAWRENCE_ORR_RD	Location: SE
ADA ID: FB639843B4AB	Ramp Type: BlendTrans1	Initial Pass/Fail: Fail	Overall Compliance: No
Severity Score: 1.25			
Codes/Mitigation Info/Possible Solution		Field Measurements/Component Compliance

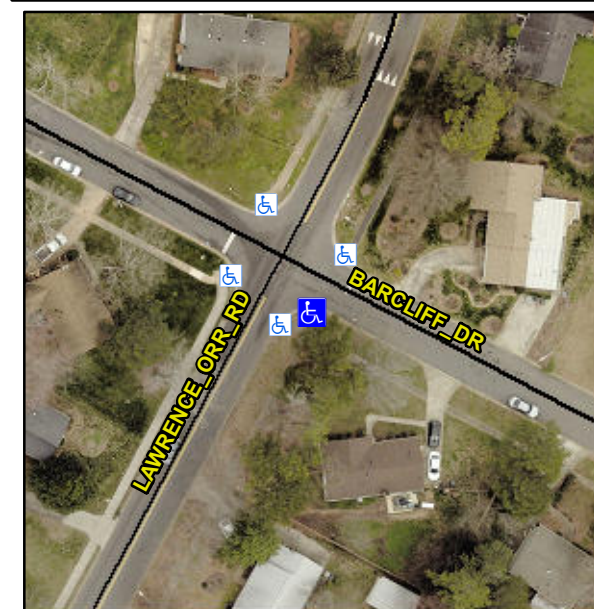
**Not Found, R304.5.3**

Compliance	Description	Data	Compliance	Description	Data
N/A	Ramp Length (in)	47.5	Yes	BlendTrans Slope (%)	4.7
Yes	Ramp Width (in)	48.0	No	BlendTrans XSlope (%)	3.0
N/A	Flare Type LT	N/A	N/A	Flare Type RT	N/A
N/A	Flare Slope LT (%)	N/A	N/A	Flare Slope RT (%)	N/A
N/A	Flare Traversable LT?	N/A	N/A	Flare Traversable RT?	N/A
N/A	Landing Length (in)	N/A	N/A	DWS Provided?	N/A
N/A	Landing Width (in)	N/A	N/A	DWS Contrast?	N/A
N/A	Landing Slope (%)	N/A	N/A	DWS Length (in)	N/A
N/A	Landing X Slope (%)	N/A	N/A	DWS Full Width?	N/A
N/A	Landing Curb? (Y/N)	N/A	N/A	DWS Offset (in)	N/A
N/A	Shared Landing?	N/A			
N/A	Gutter Ponding?	N/A	N/A	Gutter Slope (%)	N/A
N/A	Gutter Lip Ht (in)	N/A	N/A	Gutter X Slope (%)	N/A
N/A	Painted X Walk1?	No	N/A	Painted X Walk2?	N/A
	X Walk 1 Direction	To NE		X Walk 2 Direction	N/A
	X Walk 1 Width (in)	N/A		X Walk 2 Width (in)	N/A
	X Walk 1 Slope (%)	0.4		X Walk 2 Slope (%)	N/A
	X Walk 1 X Slope (%)	4.9		X Walk 2 X Slope (%)	N/A

N/A	Ramp inside XWalk1?	N/A	N/A	Ramp inside XWalk2?	N/A
	Road Slope (%)	4.9		Clear Space?	N/A
	Road X Slope (%)	0.4	N/A	Clear Space to XWalk (in)	N/A
N/A	Any Obstructions?	N/A	N/A	Storm Grate/Utility Hazard?	N/A
	Obstruction Type			Storm Grate/Utility Type	
		N/A			N/A
			Yes	Surface Condition? (G/P)	Good
			No	Curb Slope (%)	10.6

**Remove & Replace Curb Ramp With Two New Directional Ramps or Equivalent.**
