# Access Compliance Report

## Public Rights-of-Way

### (Curb Ramps)

| Intersection ID: 10014702 | Main Street: PERIWINKLE_HILL_CT | Cross Street: N/A | Location: E |

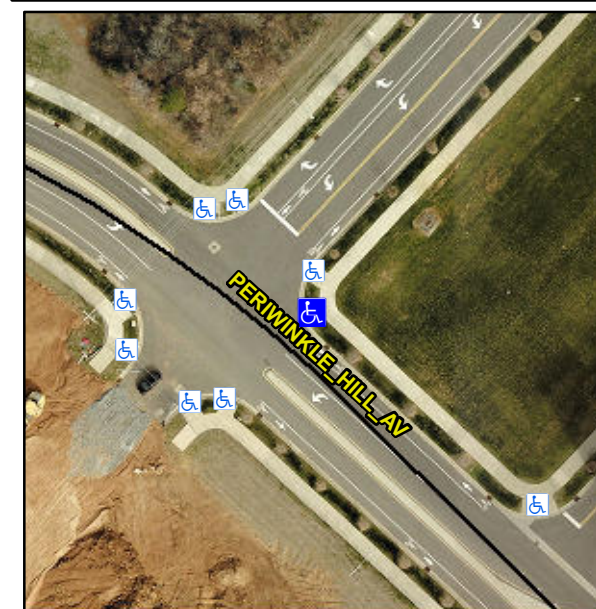
**R305.2**

| Compliance | Description | Data | Compliance | Description | Data |
|---|---|---|---|---|---|
| N/A | Landing Curb? (Y/N) | No | No | DWS Offset (in) | 6.0 |

**Remove & Replace Detectable Warning System.**

**\$ 800.00**
