# Access Compliance Report

## Public Rights-of-Way

### (Curb Ramps)

Intersection ID: 13247	Main Street: MERRIMAN_AV	Cross Street: W_KINGSTON_AV	Location: E
ADA ID: FB6D92B8ECDD	Ramp Type: ParaDiag	Initial Pass/Fail: Fail	Overall Compliance: No
			Severity Score: 26.25

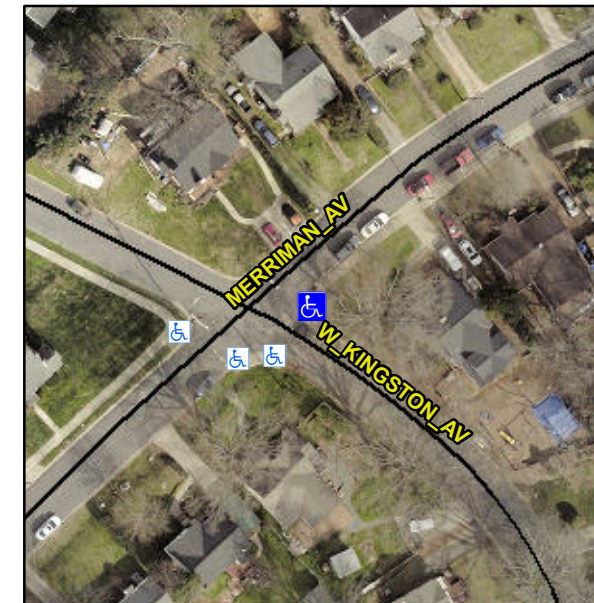
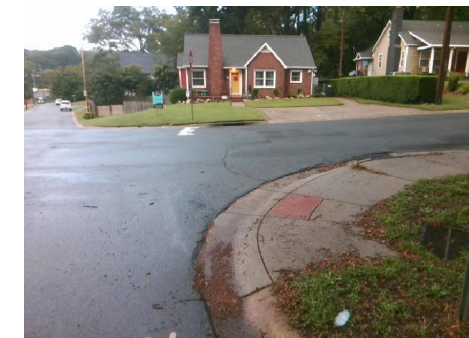
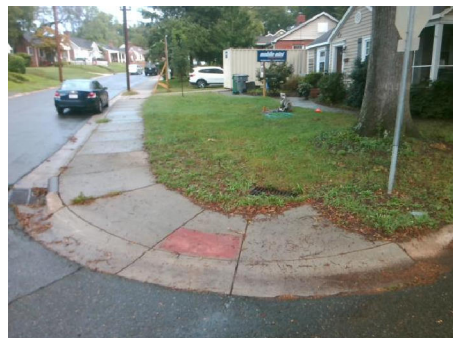
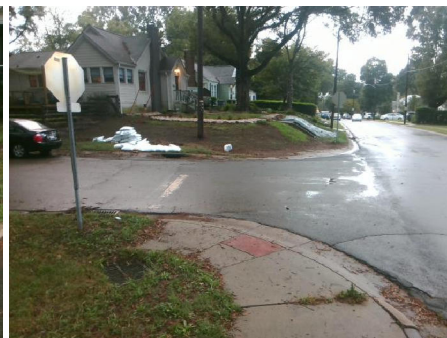
Compliance	Description	Data	Compliance	Description	Data
N/A	Ramp Length LT (in)	45.0	N/A	Ramp Length RT (in)	N/A
Yes	Ramp Width LT (in)	60.0	N/A	Ramp Width RT (in)	N/A
No	Ramp Slope LT (%)	13.1	N/A	Ramp Slope RT (%)	N/A
No	Ramp XSlope LT (%)	3.4	N/A	Ramp XSlope RT (%)	N/A
N/A	Landing Length (in)	N/A	N/A	DWS Provided?	N/A
N/A	Landing Width (in)	N/A	N/A	DWS Contrast?	N/A
N/A	Landing Slope (%)	N/A	N/A	DWS Length (in)	N/A
N/A	Landing X Slope (%)	N/A	N/A	DWS Full Width?	N/A
N/A	Landing Curb? (Y/N)	N/A	N/A	DWS Offset (in)	N/A
N/A	Shared Landing?	N/A			
N/A	Gutter Ponding?	N/A	N/A	Gutter Slope (%)	N/A
N/A	Gutter Lip Ht (in)	N/A	N/A	Gutter X Slope (%)	N/A
N/A	Painted X Walk1?	No	N/A	Painted X Walk2?	No
	X Walk 1 Direction	To NW		X Walk 2 Direction	To SW
N/A	X Walk 1 Width (in)	N/A	N/A	X Walk 2 Width (in)	N/A
	X Walk 1 Slope (%)	6.0		X Walk 2 Slope (%)	3.0
	X Walk 1 X Slope (%)	4.0		X Walk 2 X Slope (%)	0.7
N/A	Ramp inside XWalk1?	N/A	N/A	Ramp inside XWalk2?	N/A

Road Slope (%)	1.5	N/A	Clear Space?	N/A
	Road X Slope (%)	2.1	N/A	Clear Space to XWalk (in)	N/A
N/A	Any Obstructions?	N/A	N/A	Storm Grate/Utility Hazard?	N/A
	Obstruction Type			Storm Grate/Utility Type	
		N/A			N/A
			Yes	Surface Condition? (G/P)	Good
			N/A	Curb Slope (%)	8.9

**Remove & Replace Curb Ramp With Two New Directional Ramps or Equivalent.**
