Access Compliance Report

Public Rights-of-Way

(Curb Ramps)

Intersection ID: 10037035	Main Street: S_TRYON_ST	Cross Street: N/A	Location:	N
ADA ID: FB76C27840D3	Ramp Type: Perp	Initial Pass/Fail: Pass	Overall Compliance: No	Severity Score: 0
Codes/Mitigation Info/Possible Solution		Field Measurements/Component Compliance

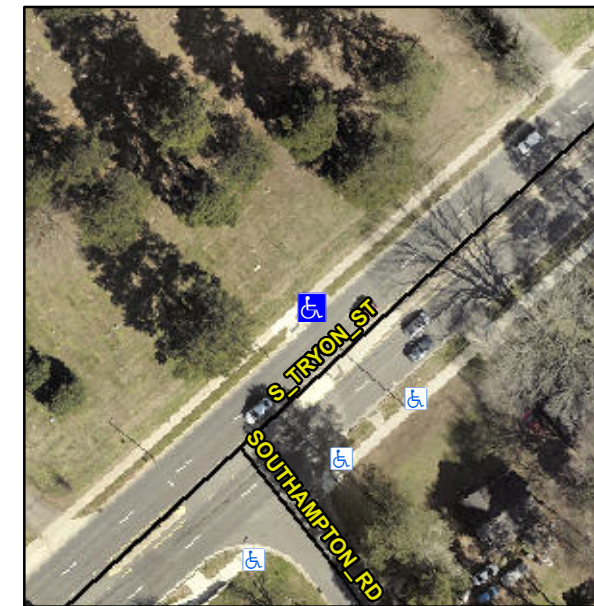
Compliance	Description	Data	Compliance	Description	Data
N/A	Ramp Length (in)	61.0	Yes	Ramp Slope (%)	5.8
Yes	Ramp Width (in)	84.1	Yes	Ramp XSlope (%)	1.5
N/A	Flare Type LT	Sloped	N/A	Flare Type RT	N/A
N/A	Flare Slope LT (%)	4.0	N/A	Flare Slope RT (%)	6.7
N/A	Flare Traversable LT?	Yes	N/A	Flare Traversable RT?	No
Yes	Landing Length (in)	59.0	Yes	DWS Provided?	Yes
Yes	Landing Width (in)	84.0	Yes	DWS Contrast?	Yes
Yes	Landing Slope (%)	0.3	Yes	DWS Length (in)	24.0
Yes	Landing X Slope (%)	1.6	Yes	DWS Full Width?	Yes
N/A	Landing Curb? (Y/N)	No	No	DWS Offset (in)	2.5
N/A	Shared Landing?	No			
Yes	Gutter Ponding?	No	Yes	Gutter Slope (%)	0.0
Yes	Gutter Lip Ht (in)	0.0	Yes	Gutter X Slope (%)	0.5
N/A	Painted X Walk1?	No	N/A	Painted X Walk2?	N/A
	X Walk 1 Direction	To SE		X Walk 2 Direction	N/A
N/A	X Walk 1 Width (in)	N/A	N/A	X Walk 2 Width (in)	N/A
	X Walk 1 Slope (%)	0.7		X Walk 2 Slope (%)	N/A
	X Walk 1 X Slope (%)	1.6		X Walk 2 X Slope (%)	N/A

N/A	Ramp inside XWalk1?	N/A	N/A	Ramp inside XWalk2?	N/A
	Road Slope (%)	N/A	N/A	Clear Space?	Yes
	Road X Slope (%)	N/A	N/A	Clear Space to XWalk (in)	N/A
Yes	Any Obstructions?	No	Yes	Storm Grate/Utility Hazard?	No
	Obstruction Type			Storm Grate/Utility Type	
		N/A			N/A
			Yes	Surface Condition? (G/P)	Good

Possible Solutions:

Remove & Replace Detectable Warning System.

R305.2
