Access Compliance Report

Public Rights-of-Way

(Curb Ramps)

Intersection ID: 14086	Main Street: BALDWIN_AV	Cross Street: E_3RD_ST	Location: SW
ADA ID: FB7AD5335631	Ramp Type: Perp	Initial Pass/Fail: Fail	Overall Compliance: No
		Severity Score: 30

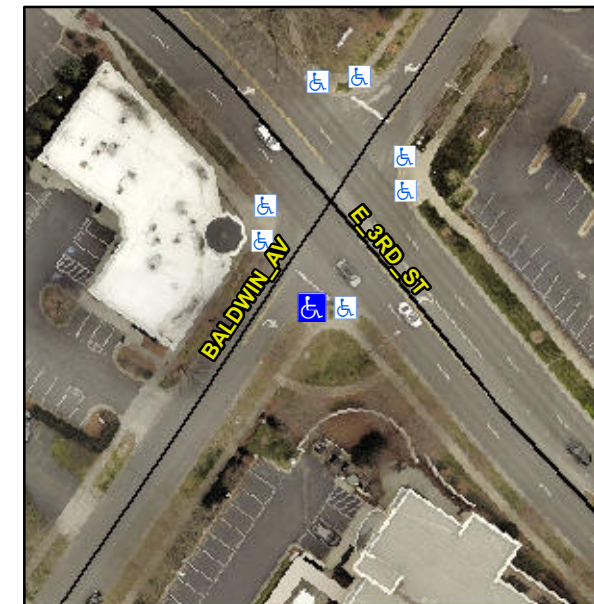
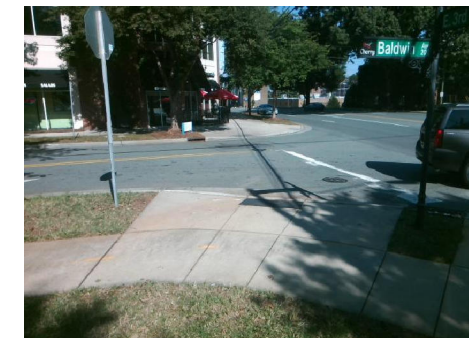
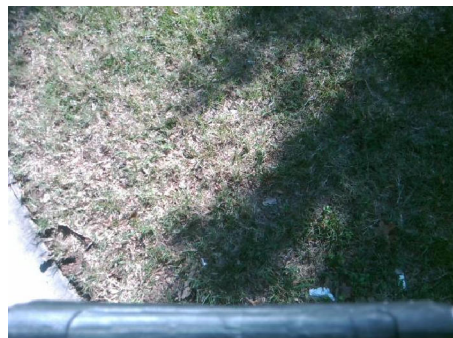
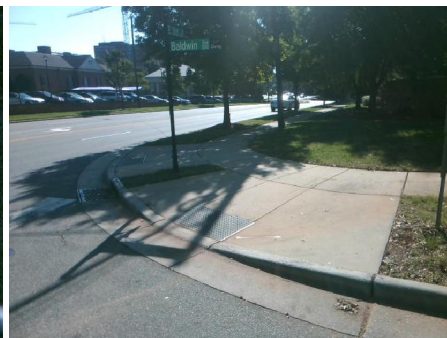
Compliance	Description	Data	Compliance	Description	Data
N/A	Ramp Length (in)	85.5	No	Ramp Slope (%)	9.5
No	Ramp Width (in)	34.5	Yes	Ramp XSlope (%)	1.0
N/A	Flare Type LT	N/A	N/A	Flare Type RT	N/A
N/A	Flare Slope LT (%)	N/A	N/A	Flare Slope RT (%)	N/A
N/A	Flare Traversable LT?	N/A	N/A	Flare Traversable RT?	N/A
N/A	Landing Length (in)	N/A	N/A	DWS Provided?	N/A
N/A	Landing Width (in)	N/A	N/A	DWS Contrast?	N/A
N/A	Landing Slope (%)	N/A	N/A	DWS Length (in)	N/A
N/A	Landing X Slope (%)	N/A	N/A	DWS Full Width?	N/A
N/A	Landing Curb? (Y/N)	N/A	N/A	DWS Offset (in)	N/A
N/A	Shared Landing?	N/A			
N/A	Gutter Ponding?	N/A	N/A	Gutter Slope (%)	N/A
N/A	Gutter Lip Ht (in)	N/A	N/A	Gutter X Slope (%)	N/A
N/A	Painted X Walk1?	No	N/A	Painted X Walk2?	N/A
	X Walk 1 Direction	To NW		X Walk 2 Direction	N/A
N/A	X Walk 1 Width (in)	N/A	N/A	X Walk 2 Width (in)	N/A
	X Walk 1 Slope (%)	0.5		X Walk 2 Slope (%)	N/A
	X Walk 1 X Slope (%)	1.0		X Walk 2 X Slope (%)	N/A

N/A	Ramp inside XWalk1?	N/A	N/A	Ramp inside XWalk2?	N/A
	Road Slope (%)	N/A	N/A	Clear Space?	N/A
	Road X Slope (%)	N/A	N/A	Clear Space to XWalk (in)	N/A
N/A	Any Obstructions?	N/A	N/A	Storm Grate/Utility Hazard?	N/A
	Obstruction Type			Storm Grate/Utility Type	
		N/A			N/A
			Yes	Surface Condition? (G/P)	Good

Remove & Replace Entire Ramp.

R304.5.1, R304.2.2
