Access Compliance Report

Public Rights-of-Way

(Curb Ramps)

Intersection ID: 8186	Main Street: CINDERELLA_RD	Cross Street: YUMA_ST	Location:	N
ADA ID: FB8C43B8F4D7	Ramp Type: Directional1	Initial Pass/Fail: Fail	Overall Compliance: No	Severity Score: 46.25

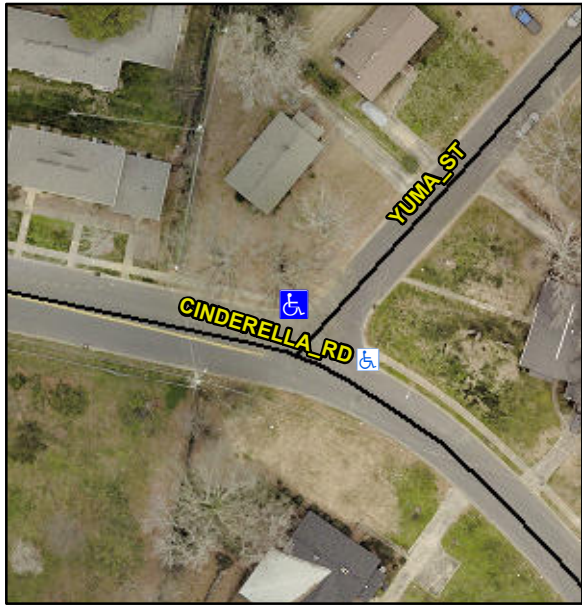
Possible Solutions:		Compliance	Description	Data	Compliance	Description	Data
	Remove & Replace Entire Ramp.		N/A	Ramp Length (in)	61.0	N/A	Grade Break?	N/A
			No	Ramp Width (in)	37.5	N/A	Grade Break Slope (%)	0.0
			No	Ramp Slope (%)	9.6	N/A	Grade Break XSlope (%)	0.0
			No	Ramp XSlope (%)	9.5			
			N/A	Flare Type LT	N/A	N/A	Flare Type RT	N/A
			N/A	Flare Slope LT (%)	N/A	N/A	Flare Slope RT (%)	0.0
			N/A	Flare Traversable LT?	N/A	N/A	Flare Traversable RT?	N/A
			N/A	Landing Length (in)	0.0	N/A	DWS Provided?	N/A
			N/A	Landing Width (in)	0.0	N/A	DWS Contrast?	N/A
Surveyor Notes:		N/A	N/A	Landing Slope (%)	0.0	N/A	DWS Length (in)	N/A
		N/A	N/A	Landing X Slope (%)	0.0	N/A	DWS Full Width?	N/A
PROW/ADA:		R304.5.1, R304.2.2, R304.5.3	N/A	Landing Curb? (Y/N)	N/A	N/A	DWS Offset LT (in)	N/A
			N/A	Shared Landing?	N/A	N/A	DWS Offset RT (in)	N/A

N/A	Gutter Ponding?	0.0	N/A	Gutter Slope (%)	N/A
			N/A	Gutter Lip Ht (in)	0.0	N/A	Gutter X Slope (%)	N/A
			N/A	Painted X Walk1?	No		Road Slope (%)	1.8
				X Walk 1 Direction	To SE		Road X Slope (%)	0.5
				X Walk 1 Width (in)	N/A		Clear Space?	N/A
				X Walk 1 Slope (%)	1.8	N/A	Clear Space to XWalk (in)	N/A
				X Walk 1 X Slope (%)	0.5	N/A	Storm Grate/Utility Hazard?	N/A
			N/A	Ramp inside XWalk1?	N/A		Storm Grate/Utility Type	
			N/A	Any Obstructions?	N/A			N/A
				Obstruction Type		Yes	Surface Condition? (G/P)	Good
					N/A	N/A	Curb Slope (%)	15.6
Total Cost:		\$ 1600.00
