# Access Compliance Report

## Public Rights-of-Way

### (Curb Ramps)

Intersection ID: 50599	Main Street: HEARTLEAF_RD	Cross Street: STREAM_ORCHID_LN	Location: NE
ADA ID: FB8CE8E051B6	Ramp Type: Perp	Initial Pass/Fail: Fail	Overall Compliance: No
Codes/Mitigation Info/Possible Solution		Field Measurements/Component Compliance	
Severity Score: 21.25

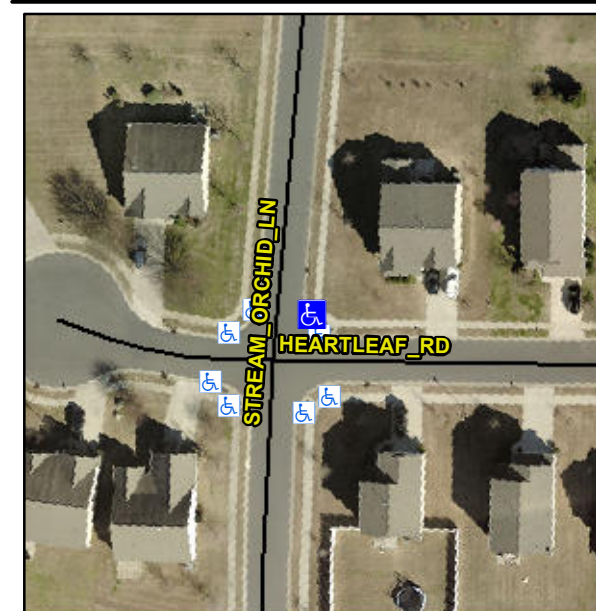
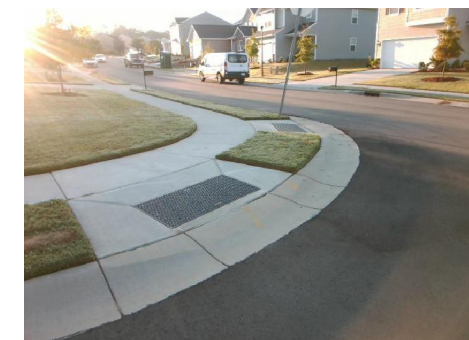
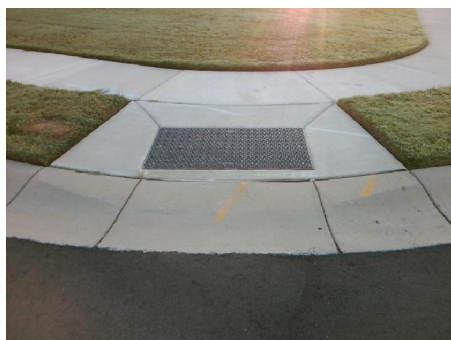
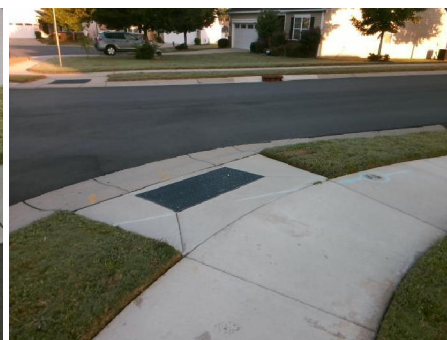
**Not Found, R304.5.1, R304.2.2**

Compliance	Description	Data	Compliance	Description	Data
N/A	Ramp Length (in)	48.0	No	Ramp Slope (%)	9.9
No	Ramp Width (in)	47.5	Yes	Ramp XSlope (%)	1.5
N/A	Flare Type LT	N/A	N/A	Flare Type RT	N/A
N/A	Flare Slope LT (%)	N/A	N/A	Flare Slope RT (%)	N/A
N/A	Flare Traversable LT?	N/A	N/A	Flare Traversable RT?	N/A
N/A	Landing Length (in)	N/A	N/A	DWS Provided?	N/A
N/A	Landing Width (in)	N/A	N/A	DWS Contrast?	N/A
N/A	Landing Slope (%)	N/A	N/A	DWS Length (in)	N/A
N/A	Landing X Slope (%)	N/A	N/A	DWS Full Width?	N/A
N/A	Landing Curb? (Y/N)	N/A	N/A	DWS Offset (in)	N/A
N/A	Shared Landing?	N/A			
N/A	Gutter Ponding?	N/A	N/A	Gutter Slope (%)	N/A
N/A	Gutter Lip Ht (in)	N/A	N/A	Gutter X Slope (%)	N/A
N/A	Painted X Walk1?	No	N/A	Painted X Walk2?	N/A
	X Walk 1 Direction	To W		X Walk 2 Direction	N/A
N/A	X Walk 1 Width (in)	N/A	N/A	X Walk 2 Width (in)	N/A
	X Walk 1 Slope (%)	4.5		X Walk 2 Slope (%)	N/A
	X Walk 1 X Slope (%)	0.6		X Walk 2 X Slope (%)	N/A

N/A	Ramp inside XWalk1?	N/A	N/A	Ramp inside XWalk2?	N/A
	Road Slope (%)	N/A	N/A	Clear Space?	N/A
	Road X Slope (%)	N/A	N/A	Clear Space to XWalk (in)	N/A
N/A	Any Obstructions?	N/A	N/A	Storm Grate/Utility Hazard?	N/A
	Obstruction Type			Storm Grate/Utility Type	
		N/A			N/A
			Yes	Surface Condition? (G/P)	Good

**Remove & Replace Entire Ramp.**

Total Cost: \$ 1850.00
