# Access Compliance Report

## Public Rights-of-Way

### (Curb Ramps)

| Intersection ID: 11775 | Main Street: E_18TH_ST | Cross Street: SEIGLE_AV | Location: N |

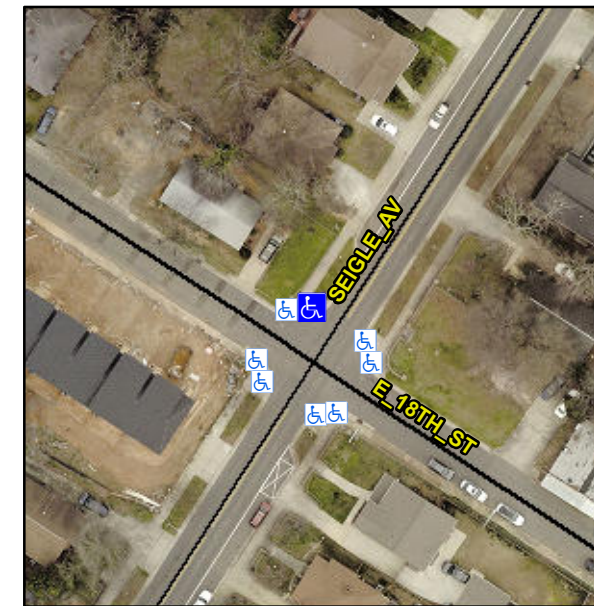
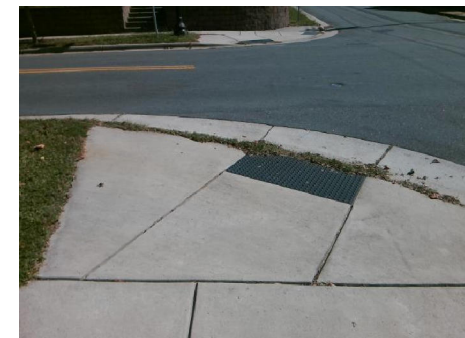
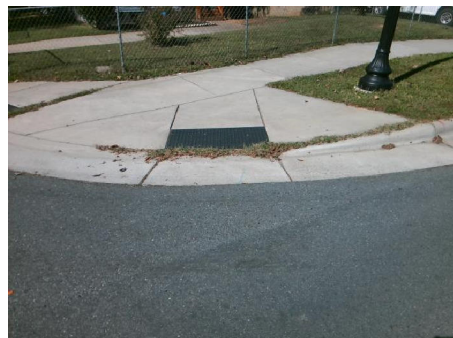
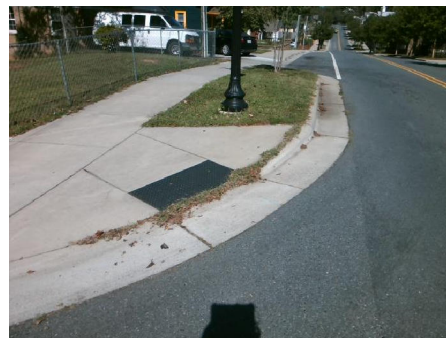
| ADA ID: FB8D1AAF7C54 | Ramp Type: BlendTrans1 | Initial Pass/Fail: Fail | Overall Compliance: No |
| | | | Severity Score: 21.25 |

**R304.5.1, R304.5.3**

| Compliance | Description | Data | Compliance | Description | Data |
|---|---|---|---|---|---|
| No | Ramp Width (in) | 47.5 | No | BlendTrans XSlope (%) | 6.5 |

**Remove & Replace Curb Ramp With Two New Directional Ramps or Equivalent.**

Total Cost: \$ 3200.00
