# Access Compliance Report

## Public Rights-of-Way

### (Curb Ramps)

Intersection ID: 22250	Main Street: SHARON_LAKES_RD	Cross Street: SOUTH_BV	Location: NE
ADA ID: FB8F2F9A7022	Ramp Type: PerpDiag	Initial Pass/Fail: Fail	Overall Compliance: No
Severity Score: 26.25			
Codes/Mitigation Info/Possible Solution		Field Measurements/Component Compliance

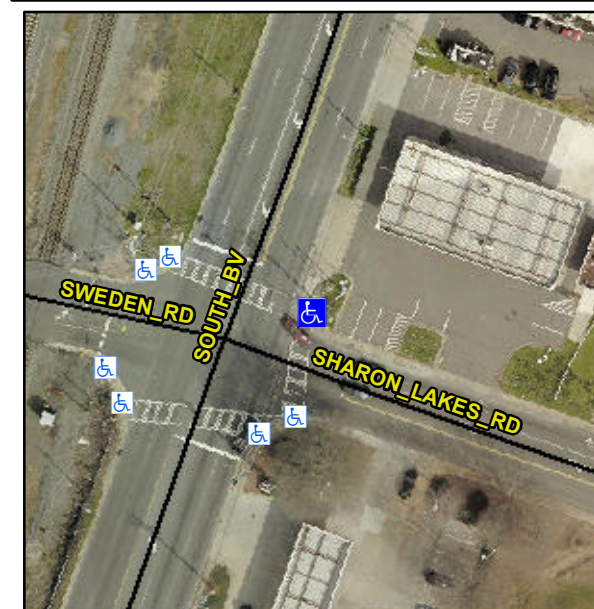
**Not Found, R304.2.2, R304.5.3**

Compliance	Description	Data	Compliance	Description	Data
N/A	Ramp Length (in)	48.0	No	Ramp Slope (%)	13.8
Yes	Ramp Width (in)	48.0	No	Ramp XSlope (%)	4.3
N/A	Flare Type LT	N/A	N/A	Flare Type RT	N/A
N/A	Flare Slope LT (%)	N/A	N/A	Flare Slope RT (%)	N/A
N/A	Flare Traversable LT?	N/A	N/A	Flare Traversable RT?	N/A
N/A	Landing Length (in)	N/A	N/A	DWS Provided?	N/A
N/A	Landing Width (in)	N/A	N/A	DWS Contrast?	N/A
N/A	Landing Slope (%)	N/A	N/A	DWS Length (in)	N/A
N/A	Landing X Slope (%)	N/A	N/A	DWS Full Width?	N/A
N/A	Landing Curb? (Y/N)	N/A	N/A	DWS Offset (in)	N/A
N/A	Shared Landing?	N/A			
N/A	Gutter Ponding?	N/A	N/A	Gutter Slope (%)	N/A
N/A	Gutter Lip Ht (in)	N/A	N/A	Gutter X Slope (%)	N/A
N/A	Painted X Walk1?	Yes	N/A	Painted X Walk2?	Yes
	X Walk 1 Direction	To NW		X Walk 2 Direction	To SW
N/A	X Walk 1 Width (in)	119.0	N/A	X Walk 2 Width (in)	101.0
	X Walk 1 Slope (%)	1.3		X Walk 2 Slope (%)	2.4
	X Walk 1 X Slope (%)	1.0		X Walk 2 X Slope (%)	2.3

N/A	Ramp inside XWalk1?	Yes	N/A	Ramp inside XWalk2?	Yes
	Road Slope (%)	0.5	N/A	Clear Space?	N/A
	Road X Slope (%)	2.3	N/A	Clear Space to XWalk (in)	N/A
N/A	Any Obstructions?	N/A	N/A	Storm Grate/Utility Hazard?	N/A
	Obstruction Type			Storm Grate/Utility Type	
		N/A			N/A
		Yes		Surface Condition? (G/P)	Good

**Remove & Replace Curb Ramp With Two New Directional Ramps or Equivalent.**
