Access Compliance Report

Public Rights-of-Way

(Curb Ramps)

Intersection ID: 53228	Main Street: FLEETWOOD_DR	Cross Street: MAJOR_SAMUALS_WY	Location: SE
ADA ID: FBA64BF8C070	Ramp Type: Perp	Initial Pass/Fail: Fail	Overall Compliance: No
Severity Score: 13.75			
Codes/Mitigation Info/Possible Solution		Field Measurements/Component Compliance

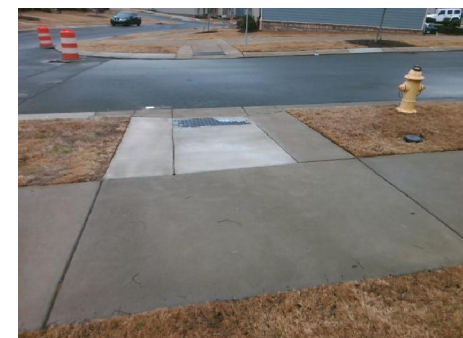
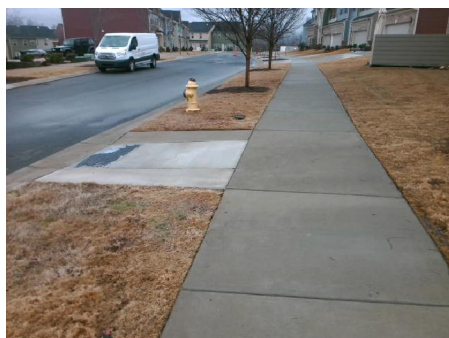
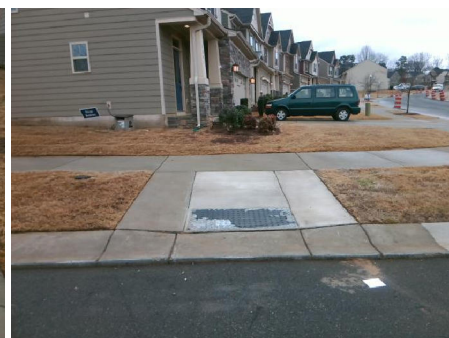
Not Found, R304.2.2, R304.5.3

Compliance	Description	Data	Compliance	Description	Data
N/A	Ramp Length (in)	96.0	No	Ramp Slope (%)	9.8
Yes	Ramp Width (in)	50.0	No	Ramp XSlope (%)	2.1
N/A	Flare Type LT	N/A	N/A	Flare Type RT	N/A
N/A	Flare Slope LT (%)	N/A	N/A	Flare Slope RT (%)	N/A
N/A	Flare Traversable LT?	N/A	N/A	Flare Traversable RT?	N/A
N/A	Landing Length (in)	N/A	N/A	DWS Provided?	N/A
N/A	Landing Width (in)	N/A	N/A	DWS Contrast?	N/A
N/A	Landing Slope (%)	N/A	N/A	DWS Length (in)	N/A
N/A	Landing X Slope (%)	N/A	N/A	DWS Full Width?	N/A
N/A	Landing Curb? (Y/N)	N/A	N/A	DWS Offset (in)	N/A
N/A	Shared Landing?	N/A			
N/A	Gutter Ponding?	N/A	N/A	Gutter Slope (%)	N/A
N/A	Gutter Lip Ht (in)	N/A	N/A	Gutter X Slope (%)	N/A
N/A	Painted X Walk1?	No	N/A	Painted X Walk2?	N/A
	X Walk 1 Direction	To N		X Walk 2 Direction	N/A
N/A	X Walk 1 Width (in)	N/A	N/A	X Walk 2 Width (in)	N/A
	X Walk 1 Slope (%)	3.4		X Walk 2 Slope (%)	N/A
	X Walk 1 X Slope (%)	3.2		X Walk 2 X Slope (%)	N/A

N/A	Ramp inside XWalk1?	N/A	N/A	Ramp inside XWalk2?	N/A
	Road Slope (%)	N/A	N/A	Clear Space?	N/A
	Road X Slope (%)	N/A	N/A	Clear Space to XWalk (in)	N/A
N/A	Any Obstructions?	N/A	N/A	Storm Grate/Utility Hazard?	N/A
	Obstruction Type			Storm Grate/Utility Type	
		N/A			N/A
			Yes	Surface Condition? (G/P)	Good

Remove & Replace Entire Ramp.

Total Cost: \$ 1850.00
