# Access Compliance Report

## Public Rights-of-Way

### (Curb Ramps)

Intersection ID: 10021330	Main Street: BLAKENEY_HEATH_RD	Cross Street: N/A	Location: SW
ADA ID: FBB0E12CD934	Ramp Type: BlendTrans2	Initial Pass/Fail: Fail	Overall Compliance: No
Severity Score: 1.25			
Codes/Mitigation Info/Possible Solution		Field Measurements/Component Compliance

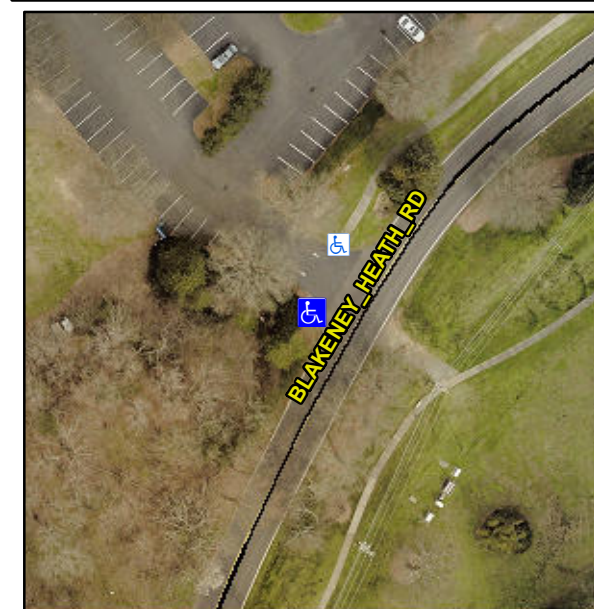
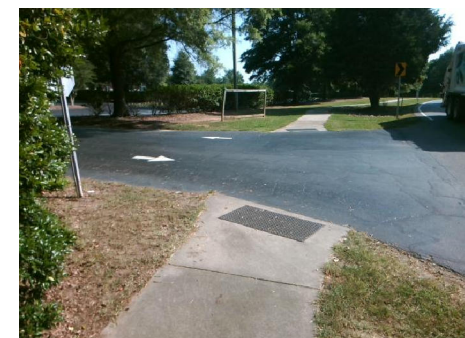
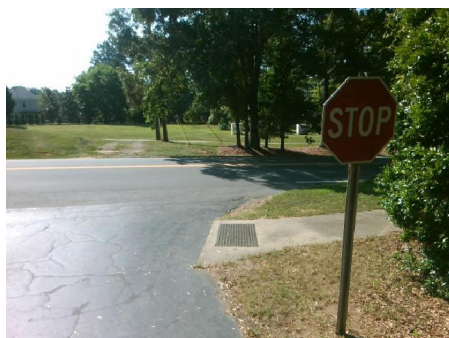
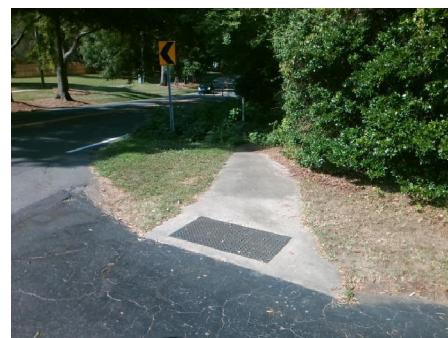
**SIDEWALK BEHIND RAMP SLANTS DOWN 5%, Entrance???**

**R304.5.3**

Compliance	Description	Data	Compliance	Description	Data
N/A	Ramp Length (in)	64.0	Yes	BlendTrans Slope (%)	4.3
Yes	Ramp Width (in)	48.0	No	BlendTrans XSlope (%)	2.3
N/A	Flare Type LT	N/A	N/A	Flare Type RT	N/A
N/A	Flare Slope LT (%)	N/A	N/A	Flare Slope RT (%)	N/A
N/A	Flare Traversable LT?	N/A	N/A	Flare Traversable RT?	N/A
N/A	Landing Length (in)	N/A	N/A	DWS Provided?	N/A
N/A	Landing Width (in)	N/A	N/A	DWS Contrast?	N/A
N/A	Landing Slope (%)	N/A	N/A	DWS Length (in)	N/A
N/A	Landing X Slope (%)	N/A	N/A	DWS Full Width?	N/A
N/A	Landing Curb? (Y/N)	N/A	N/A	DWS Offset (in)	N/A
N/A	Shared Landing?	N/A			
N/A	Gutter Ponding?	N/A	N/A	Gutter Slope (%)	N/A
N/A	Gutter Lip Ht (in)	N/A	N/A	Gutter X Slope (%)	N/A
N/A	Painted X Walk1?	No	N/A	Painted X Walk2?	N/A
	X Walk 1 Direction	To N		X Walk 2 Direction	N/A
	X Walk 1 Width (in)	N/A		X Walk 2 Width (in)	N/A
	X Walk 1 Slope (%)	5.2		X Walk 2 Slope (%)	N/A
	X Walk 1 X Slope (%)	2.7		X Walk 2 X Slope (%)	N/A

N/A	Ramp inside XWalk1?	N/A	N/A	Ramp inside XWalk2?	N/A
	Road Slope (%)	2.7		Clear Space?	N/A
	Road X Slope (%)	5.2	N/A	Clear Space to XWalk (in)	N/A
N/A	Any Obstructions?	N/A	N/A	Storm Grate/Utility Hazard?	N/A
	Obstruction Type			Storm Grate/Utility Type	
		N/A			N/A
			Yes	Surface Condition? (G/P)	Good
			N/A	Curb Slope (%)	0.4

**Remove & Replace Curb Ramp With Two New Directional Ramps or Equivalent.**
