Intersection ID: 16451	Main Street: HARTFORD_AV	Cross Street: HOLLIS_RD	Location:	NW
ADA ID: FBB6AB337053	Ramp Type: Perp	Initial Pass/Fail: Fail	Overall Compliance: No	Severity Score: 12.5

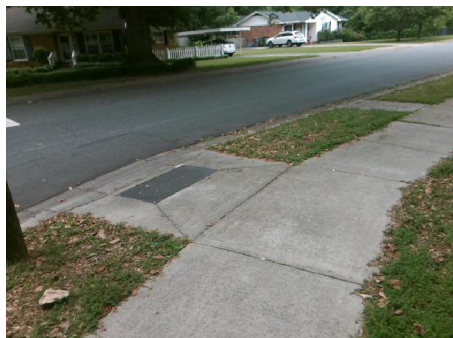
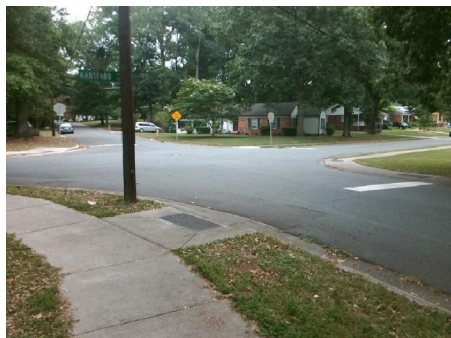
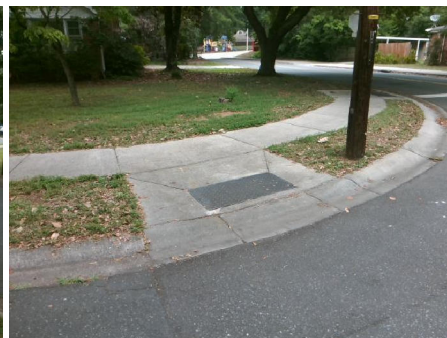
Codes/Mitigation Info/Possible Solution			Field Measurements/Component Compliance					
	Possible Solutions:		Compliance	Description	Data	Compliance	Description	Data
	Remove & Replace Entire Ramp.		N/A	Ramp Length (in)	62.0	Yes	Ramp Slope (%)	6.4
			Yes	Ramp Width (in)	48.0	No	Ramp XSlope (%)	5.7
			N/A	Flare Type LT	N/A	N/A	Flare Type RT	N/A
			N/A	Flare Slope LT (%)	N/A	N/A	Flare Slope RT (%)	N/A
			N/A	Flare Traversable LT?	N/A	N/A	Flare Traversable RT?	N/A
			N/A	Landing Length (in)	N/A	N/A	DWS Provided?	N/A
Surveyor Notes:			N/A	Landing Width (in)	N/A	N/A	DWS Contrast?	N/A
	N/A		N/A	Landing Slope (%)	N/A	N/A	DWS Length (in)	N/A
			N/A	Landing X Slope (%)	N/A	N/A	DWS Full Width?	N/A
			N/A	Landing Curb? (Y/N)	N/A	N/A	DWS Offset (in)	N/A
			N/A	Shared Landing?	N/A			
			N/A	Gutter Ponding?	N/A	N/A	Gutter Slope (%)	N/A
			N/A	Gutter Lip Ht (in)	N/A	N/A	Gutter X Slope (%)	N/A
			N/A	Painted X Walk1?	No	N/A	Painted X Walk2?	N/A

X Walk 1 Direction	To S		X Walk 2 Direction	N/A
			N/A	X Walk 1 Width (in)	N/A	N/A	X Walk 2 Width (in)	N/A
				X Walk 1 Slope (%)	4.9		X Walk 2 Slope (%)	N/A
				X Walk 1 X Slope (%)	2.1		X Walk 2 X Slope (%)	N/A
			N/A	Ramp inside XWalk1?	N/A	N/A	Ramp inside XWalk2?	N/A
				Road Slope (%)	N/A	N/A	Clear Space?	N/A
				Road X Slope (%)	N/A	N/A	Clear Space to XWalk (in)	N/A
			N/A	Any Obstructions?	N/A	N/A	Storm Grate/Utility Hazard?	N/A
				Obstruction Type			Storm Grate/Utility Type	
					N/A			N/A
						Yes	Surface Condition? (G/P)	Good
Street 1 Name	HOLLIS RD							
Stop Condition-Street 2	StopSign							
Street 2 Name	N/A							
Stop Condition-Street 1	N/A							
Total Cost:	\$	1850.00
