# Access Compliance Report

## Public Rights-of-Way

### (Curb Ramps)

Intersection ID: 9954	Main Street: PARKWAY_AV	Cross Street: N/A	Location:	S
ADA ID: FB6636B71B7	Ramp Type: Directional1	Initial Pass/Fail: Fail	Overall Compliance: No	Severity Score: 35

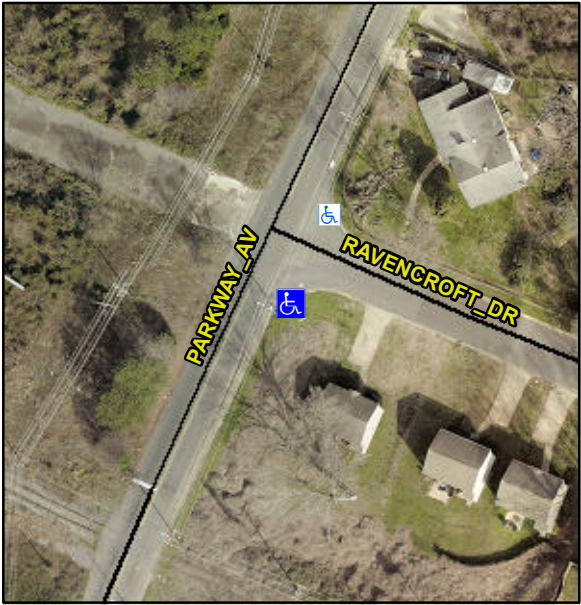
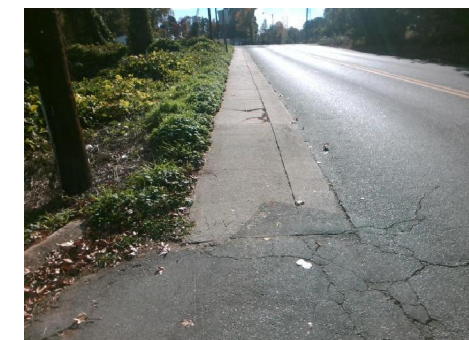
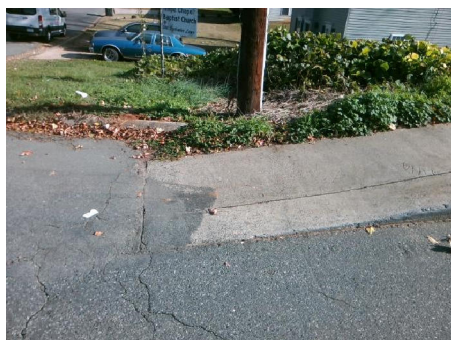
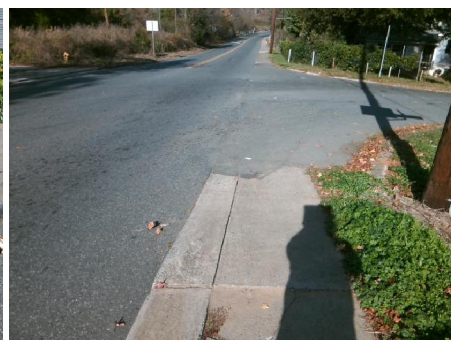
Possible Solutions:		<b>Compliance</b>	<b>Description</b>	<b>Data</b>	
	Remove & Replace Entire Ramp.		N/A	Ramp Length (in)	118.0	N/A
			No	Ramp Width (in)	38.0	N/A
			No	Ramp Slope (%)	17.1	N/A
			No	Ramp XSlope (%)	2.4	N/A
			N/A	Flare Type LT	N/A	N/A
			N/A	Flare Slope LT (%)	N/A	N/A
			N/A	Flare Traversable LT?	N/A	N/A
			N/A	Flare Type RT	N/A	N/A
			N/A	Flare Slope RT (%)	N/A	N/A
<p>Surveyor Notes:</p> <p>N/A</p>			N/A	Flare Traversable RT?	N/A	N/A
			N/A	Landing Length (in)	0.0	N/A
			N/A	Landing Width (in)	0.0	N/A
			N/A	Landing Slope (%)	0.0	N/A
			N/A	Landing X Slope (%)	0.0	N/A
			N/A	Landing Curb? (Y/N)	N/A	N/A
			N/A	Shared Landing?	N/A	N/A
			N/A	Gutter Ponding?	0.0	N/A
			N/A	Gutter Lip Ht (in)	0.0	N/A
			N/A	Painted X Walk1?	No	N/A
<p>PROW/ADA:</p> <p>R304.5.1, R304.2.2, R304.5.3</p>			N/A	X Walk 1 Direction	To N	N/A

N/A	X Walk 1 Width (in)	N/A	N/A
			N/A	X Walk 1 Slope (%)	5.7	N/A
			N/A	X Walk 1 X Slope (%)	0.0	N/A
			N/A	Ramp inside XWalk1?	N/A	N/A
			N/A	Any Obstructions?	N/A	N/A
				Obstruction Type		N/A
			Yes	Surface Condition? (G/P)		Good
			N/A	Curb Slope (%)		N/A
Total Cost:		\$ 1600.00
