# Access Compliance Report

## Public Rights-of-Way

### (Curb Ramps)

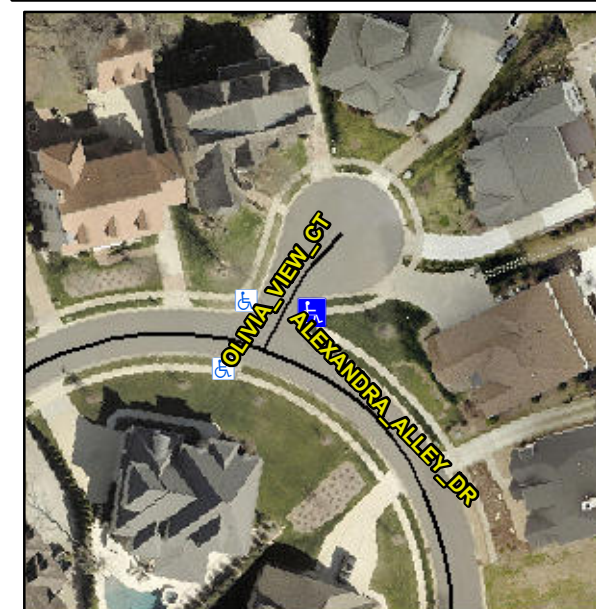
Intersection ID: 49691	Main Street: OLIVIA_VIEW_CT	Cross Street: ALEXANDRA_ALLEY_DR	Location: NE
ADA ID: FBBD20CFF081	Ramp Type: Perp	Initial Pass/Fail: Fail	Overall Compliance: No
Codes/Mitigation Info/Possible Solution			Severity Score: 10
			Field Measurements/Component Compliance

**Not Found, R304.5.1**

Compliance	Description	Data	Compliance	Description	Data
N/A	Ramp Length (in)	52.0	Yes	Ramp Slope (%)	5.5
No	Ramp Width (in)	47.0	Yes	Ramp XSlope (%)	2.5
N/A	Flare Type LT	N/A	N/A	Flare Type RT	N/A
N/A	Flare Slope LT (%)	N/A	N/A	Flare Slope RT (%)	N/A
N/A	Flare Traversable LT?	N/A	N/A	Flare Traversable RT?	N/A
N/A	Landing Length (in)	N/A	N/A	DWS Provided?	N/A
N/A	Landing Width (in)	N/A	N/A	DWS Contrast?	N/A
N/A	Landing Slope (%)	N/A	N/A	DWS Length (in)	N/A
N/A	Landing X Slope (%)	N/A	N/A	DWS Full Width?	N/A
N/A	Landing Curb? (Y/N)	N/A	N/A	DWS Offset (in)	N/A
N/A	Shared Landing?	N/A			
N/A	Gutter Ponding?	N/A	N/A	Gutter Slope (%)	N/A
N/A	Gutter Lip Ht (in)	N/A	N/A	Gutter X Slope (%)	N/A
N/A	Painted X Walk1?	No	N/A	Painted X Walk2?	N/A
	X Walk 1 Direction	To NW		X Walk 2 Direction	N/A
N/A	X Walk 1 Width (in)	N/A	N/A	X Walk 2 Width (in)	N/A
	X Walk 1 Slope (%)	6.7		X Walk 2 Slope (%)	N/A
	X Walk 1 X Slope (%)	4.0		X Walk 2 X Slope (%)	N/A

N/A	Ramp inside XWalk1?	N/A	N/A	Ramp inside XWalk2?	N/A
	Road Slope (%)	N/A	N/A	Clear Space?	N/A
	Road X Slope (%)	N/A	N/A	Clear Space to XWalk (in)	N/A
N/A	Any Obstructions?	N/A	N/A	Storm Grate/Utility Hazard?	N/A
	Obstruction Type			Storm Grate/Utility Type	
		N/A			N/A
			Yes	Surface Condition? (G/P)	Good

**Remove & Replace Entire Ramp.**

Total Cost: \$ 1850.00
