Access Compliance Report

Public Rights-of-Way

(Curb Ramps)

Intersection ID: 26811	Main Street: LINKSIDE_CT	Cross Street: OLD_COURSE_DR	Location: W
ADA ID: FBCE3B06BC20	Ramp Type: PerpDiag	Initial Pass/Fail: Fail	Overall Compliance: No
Severity Score: 33.75			
Codes/Mitigation Info/Possible Solution		Field Measurements/Component Compliance

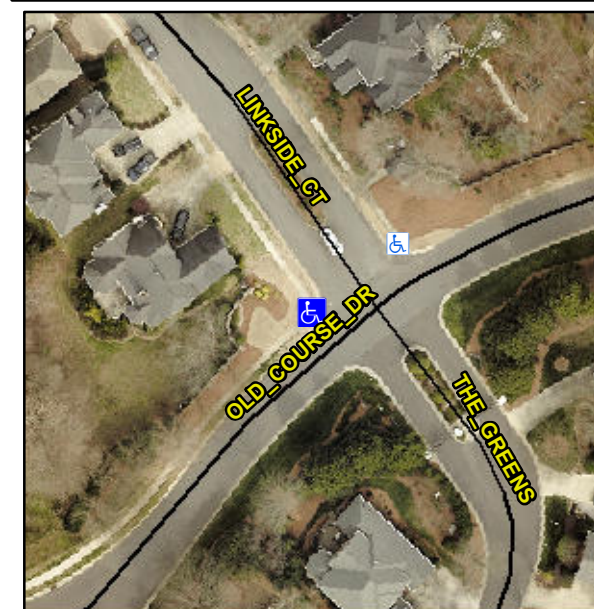
Not Found, R304.5.1, R304.5.3

Compliance	Description	Data	Compliance	Description	Data
N/A	Ramp Length (in)	94.0	Yes	Ramp Slope (%)	6.8
No	Ramp Width (in)	44.0	No	Ramp XSlope (%)	12.5
N/A	Flare Type LT	N/A	N/A	Flare Type RT	N/A
N/A	Flare Slope LT (%)	N/A	N/A	Flare Slope RT (%)	N/A
N/A	Flare Traversable LT?	N/A	N/A	Flare Traversable RT?	N/A
N/A	Landing Length (in)	N/A	N/A	DWS Provided?	N/A
N/A	Landing Width (in)	N/A	N/A	DWS Contrast?	N/A
N/A	Landing Slope (%)	N/A	N/A	DWS Length (in)	N/A
N/A	Landing X Slope (%)	N/A	N/A	DWS Full Width?	N/A
N/A	Landing Curb? (Y/N)	N/A	N/A	DWS Offset (in)	N/A
N/A	Shared Landing?	N/A			
N/A	Gutter Ponding?	N/A	N/A	Gutter Slope (%)	N/A
N/A	Gutter Lip Ht (in)	N/A	N/A	Gutter X Slope (%)	N/A
N/A	Painted X Walk1?	No	N/A	Painted X Walk2?	No
	X Walk 1 Direction	To NE		X Walk 2 Direction	To SE
N/A	X Walk 1 Width (in)	N/A	N/A	X Walk 2 Width (in)	N/A
	X Walk 1 Slope (%)	1.1		X Walk 2 Slope (%)	8.0
	X Walk 1 X Slope (%)	10.1		X Walk 2 X Slope (%)	0.9

N/A	Ramp inside XWalk1?	N/A	N/A	Ramp inside XWalk2?	N/A
	Road Slope (%)	6.3	N/A	Clear Space?	N/A
	Road X Slope (%)	5.2	N/A	Clear Space to XWalk (in)	N/A
N/A	Any Obstructions?	N/A	N/A	Storm Grate/Utility Hazard?	N/A
	Obstruction Type			Storm Grate/Utility Type	
		N/A			N/A
		Yes		Surface Condition? (G/P)	Good

Possible Solutions:

Remove & Replace Curb Ramp With Two New Directional Ramps or Equivalent.
