Access Compliance Report

Public Rights-of-Way

(Curb Ramps)

Intersection ID: 13988	Main Street: E_5TH_ST	Cross Street: LAMAR_AV	Location: NE
ADA ID: FBD2FF344426	Ramp Type: PerpDiag	Initial Pass/Fail: Fail	Overall Compliance: No
Severity Score: 8.75			
Codes/Mitigation Info/Possible Solution		Field Measurements/Component Compliance

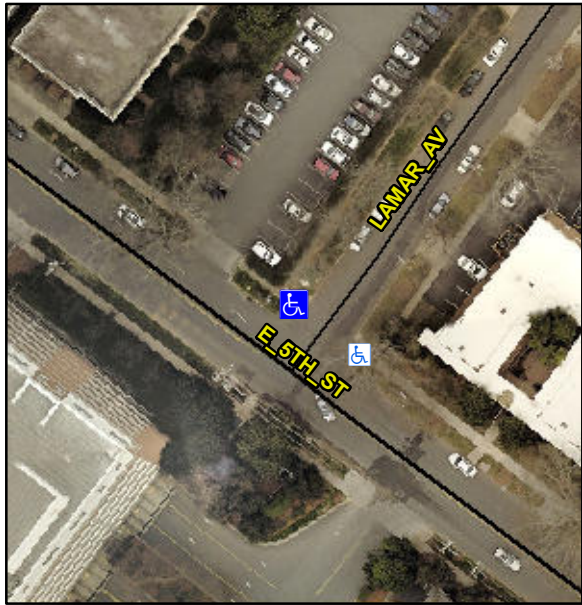
Possible Solutions:		Compliance		Description	Data	Compliance	Description	Data
	Remove & Replace Curb Ramp With Two New Directional Ramps or Equivalent.		N/A	Ramp Length (in)	86.0	Yes	Ramp Slope (%)	5.2	
			No	Ramp Width (in)	46.0	Yes	Ramp XSlope (%)	0.8	
			N/A	Flare Type LT	N/A	N/A	Flare Type RT	N/A	
			N/A	Flare Slope LT (%)	N/A	N/A	Flare Slope RT (%)	N/A	
			N/A	Flare Traversable LT?	N/A	N/A	Flare Traversable RT?	N/A	
			N/A	Landing Length (in)	N/A	N/A	DWS Provided?	N/A	
			N/A	Landing Width (in)	N/A	N/A	DWS Contrast?	N/A	
			N/A	Landing Slope (%)	N/A	N/A	DWS Length (in)	N/A	
			N/A	Landing X Slope (%)	N/A	N/A	DWS Full Width?	N/A	
Surveyor Notes:		N/A	N/A	Landing Curb? (Y/N)	N/A	N/A	DWS Offset (in)	N/A	
PROW/ADA:		Not Found, R304.5.1	N/A	Shared Landing?	N/A	N/A			
			N/A	Gutter Ponding?	N/A	N/A	Gutter Slope (%)	N/A	
			N/A	Gutter Lip Ht (in)	0.5	N/A	Gutter X Slope (%)	N/A	
			N/A	Painted X Walk1?	No	N/A	Painted X Walk2?	No

X Walk 1 Direction	To SW		X Walk 2 Direction	To SE	
			N/A	X Walk 1 Width (in)	N/A	N/A	X Walk 2 Width (in)	N/A	
				X Walk 1 Slope (%)	4.0		X Walk 2 Slope (%)	4.4	
				X Walk 1 X Slope (%)	2.0		X Walk 2 X Slope (%)	3.7	
			N/A	Ramp inside XWalk1?	N/A	N/A	Ramp inside XWalk2?	N/A	
				Road Slope (%)	1.8	N/A	Clear Space?	N/A	
				Road X Slope (%)	4.4	N/A	Clear Space to XWalk (in)	N/A	
			N/A	Any Obstructions?	N/A	N/A	Storm Grate/Utility Hazard?	N/A	
				Obstruction Type			Storm Grate/Utility Type		
					N/A			N/A	
						Yes	Surface Condition? (G/P)	Good	
Total Cost:		\$	3200.00
