Access Compliance Report Public Rights-of-Way (Curb Ramps)

Intersection ID: 29164 Main Street: GARRISON_RD Cross Street: PURPLE_BLOOM_LN Location: S

ADA ID: FBD9B32C7359 Ramp Type: PerpDiag Initial Pass/Fail: Fail Overall Compliance: No Severity Score: 33.75

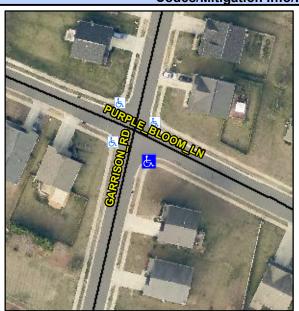
Not Found, R304.5.1, R304.5.3

Field Measurements/Component Compliance							
	Comp	liance Description	Data	Comp	liance D	escription	Data
	N/A	Ramp Length (in)	49.5	Yes	Ramp SI	lope (%)	6.9
	No	Ramp Width (in)	40.0	No	Ramp X	Slope (%)	15.9
	N/A	Flare Type LT	N/A	N/A	Flare Ty	pe RT	N/A
	N/A	Flare Slope LT (%)	N/A	N/A	Flare Slo	ope RT (%)	N/A
	N/A	Flare Traversable LT?	N/A	N/A	Flare Tra	aversable RT?	N/A
	N/A	Landing Length (in)	N/A	N/A	DWS Pr	ovided?	N/A
	N/A	Landing Width (in)	N/A	N/A	DWS Co	ontrast?	N/A
	N/A	Landing Slope (%)	N/A	N/A	DWS Le	ngth (in)	N/A
	N/A	Landing X Slope (%)	N/A	N/A	DWS Fu	II Width?	N/A
	N/A	Landing Curb? (Y/N)	N/A	N/A	DWS Of	fset (in)	N/A
	N/A	Shared Landing?	N/A				
	N/A	Gutter Ponding?	N/A	N/A	Gutter S	lope (%)	N/A
	N/A	Gutter Lip Ht (in)	N/A	N/A	Gutter X	Slope (%)	N/A
	N/A	Painted X Walk1?	No	N/A	Painted	X Walk2?	No
		X Walk 1 Direction	To NE		X Walk 2	2 Direction	To NW
	N/A	X Walk 1 Width (in)	N/A	N/A	X Walk 2	2 Width (in)	N/A

X Walk 1 Slope (%)	3.4		X Walk 2	2 Slope (%)	5.2
		X Walk 1 X Slope (%)	10.9		X Walk 2	2 X Slope (%)	10.4
	N/A	Ramp inside XWalk1?	N/A	N/A	Ramp in	side XWalk2?	N/A
		Road Slope (%)	12.9	N/A	Clear Sp	pace?	N/A
		Road X Slope (%)	2.3	N/A	Clear Sp	pace to XWalk (in)	N/A
	N/A	Any Obstructions?	N/A	N/A	Storm G	rate/Utility Hazard?	N/A
		Obstruction Type			Storm G	rate/Utility Type	
			N/A				N/A
				Yes	Surface	Condition? (G/P)	Good

Remove & Replace Curb Ramp With Two New Directional Ramps or Equivalent.

Total Cost: \$ 3200.00
