Access Compliance Report

Public Rights-of-Way

(Curb Ramps)

Intersection ID: 30581	Main Street: CIRCLEGREEN_DR	Cross Street: N/A	Location: NW
ADA ID: FBF31204C6EE	Ramp Type: PerpDiag	Initial Pass/Fail: Fail	Overall Compliance: No
Severity Score: 25			
Codes/Mitigation Info/Possible Solution		Field Measurements/Component Compliance

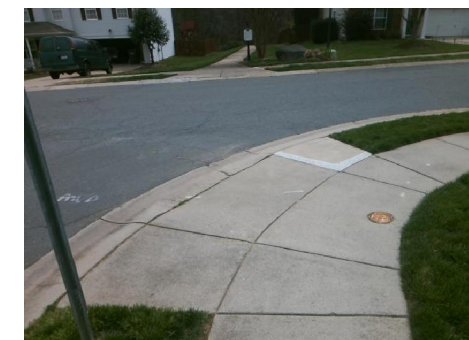
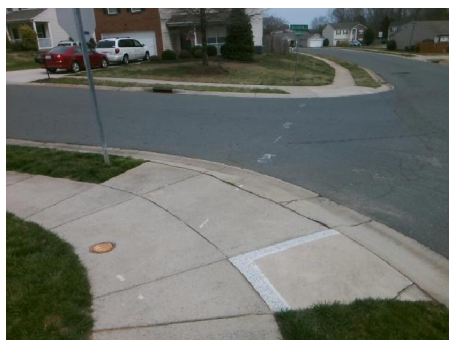
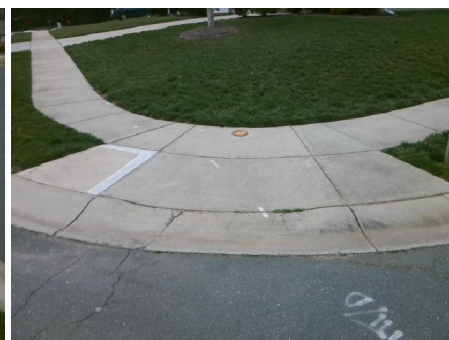
Compliance	Description	Data	Compliance	Description	Data
N/A	Ramp Length (in)	48.0	Yes	Ramp Slope (%)	6.4
Yes	Ramp Width (in)	48.0	No	Ramp XSlope (%)	10.0
N/A	Flare Type LT	N/A	N/A	Flare Type RT	N/A
N/A	Flare Slope LT (%)	N/A	N/A	Flare Slope RT (%)	N/A
N/A	Flare Traversable LT?	N/A	N/A	Flare Traversable RT?	N/A
N/A	Landing Length (in)	N/A	N/A	DWS Provided?	N/A
N/A	Landing Width (in)	N/A	N/A	DWS Contrast?	N/A
N/A	Landing Slope (%)	N/A	N/A	DWS Length (in)	N/A
N/A	Landing X Slope (%)	N/A	N/A	DWS Full Width?	N/A
N/A	Landing Curb? (Y/N)	N/A	N/A	DWS Offset (in)	N/A
N/A	Shared Landing?	N/A			
N/A	Gutter Ponding?	N/A	N/A	Gutter Slope (%)	N/A
N/A	Gutter Lip Ht (in)	N/A	N/A	Gutter X Slope (%)	N/A
N/A	Painted X Walk1?	No	N/A	Painted X Walk2?	No
	X Walk 1 Direction	To SE		X Walk 2 Direction	To NE
N/A	X Walk 1 Width (in)	N/A	N/A	X Walk 2 Width (in)	N/A
	X Walk 1 Slope (%)	1.3		X Walk 2 Slope (%)	0.7
	X Walk 1 X Slope (%)	2.3		X Walk 2 X Slope (%)	3.2

N/A	Ramp inside XWalk1?	N/A	N/A	Ramp inside XWalk2?	N/A
	Road Slope (%)	0.4	N/A	Clear Space?	N/A
	Road X Slope (%)	0.8	N/A	Clear Space to XWalk (in)	N/A
N/A	Any Obstructions?	N/A	N/A	Storm Grate/Utility Hazard?	N/A
	Obstruction Type			Storm Grate/Utility Type	
		N/A			N/A
			Yes	Surface Condition? (G/P)	Good

Remove & Replace Curb Ramp With Two New Directional Ramps or Equivalent.
