Access Compliance Report

Public Rights-of-Way

(Curb Ramps)

Intersection ID: N/A	Main Street: DALLAS_BAY_RD	Cross Street: HAMILTON_BRIDGE_RD	Location: SE
ADA ID: FBF36B57ECA2	Ramp Type: Perp	Initial Pass/Fail: Fail	Overall Compliance: No
Severity Score: 12.5			
Codes/Mitigation Info/Possible Solution		Field Measurements/Component Compliance

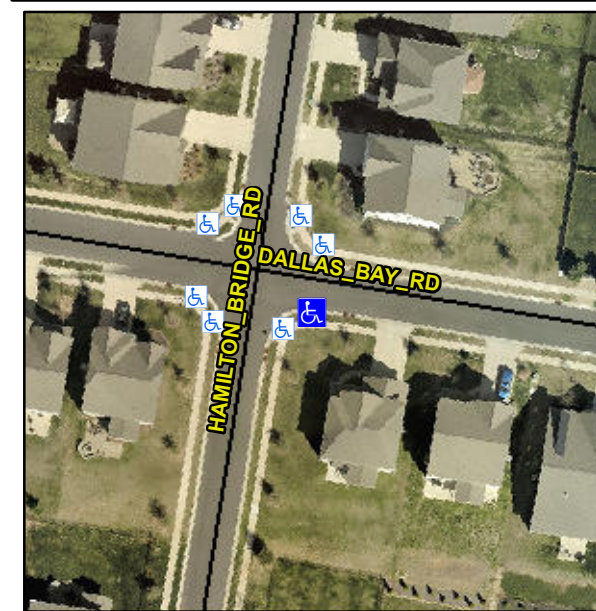
Not Found, R304.2.2

Compliance	Description	Data	Compliance	Description	Data
N/A	Ramp Length (in)	47.0	No	Ramp Slope (%)	8.5
Yes	Ramp Width (in)	49.0	Yes	Ramp XSlope (%)	2.0
N/A	Flare Type LT	N/A	N/A	Flare Type RT	N/A
N/A	Flare Slope LT (%)	N/A	N/A	Flare Slope RT (%)	N/A
N/A	Flare Traversable LT?	N/A	N/A	Flare Traversable RT?	N/A
N/A	Landing Length (in)	N/A	N/A	DWS Provided?	N/A
N/A	Landing Width (in)	N/A	N/A	DWS Contrast?	N/A
N/A	Landing Slope (%)	N/A	N/A	DWS Length (in)	N/A
N/A	Landing X Slope (%)	N/A	N/A	DWS Full Width?	N/A
N/A	Landing Curb? (Y/N)	N/A	N/A	DWS Offset (in)	N/A
N/A	Shared Landing?	N/A			
N/A	Gutter Ponding?	N/A	N/A	Gutter Slope (%)	N/A
N/A	Gutter Lip Ht (in)	1.0	N/A	Gutter X Slope (%)	N/A
N/A	Painted X Walk1?	No	N/A	Painted X Walk2?	N/A
	X Walk 1 Direction	To NE		X Walk 2 Direction	N/A
N/A	X Walk 1 Width (in)	N/A	N/A	X Walk 2 Width (in)	N/A
	X Walk 1 Slope (%)	2.2		X Walk 2 Slope (%)	N/A
	X Walk 1 X Slope (%)	0.6		X Walk 2 X Slope (%)	N/A

Possible Solutions:

Remove & Replace Entire Ramp.

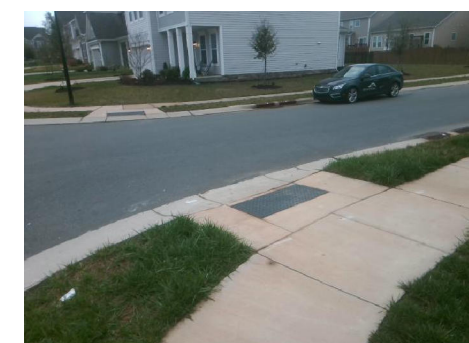
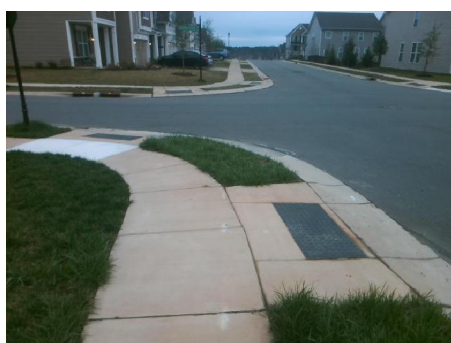
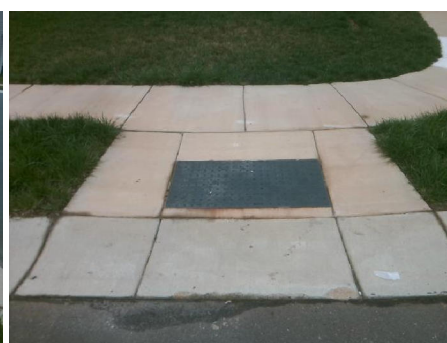
N/A	Ramp inside XWalk1?	N/A	N/A	Ramp inside XWalk2?	N/A
	Road Slope (%)	N/A	N/A	Clear Space?	N/A
	Road X Slope (%)	N/A	N/A	Clear Space to XWalk (in)	N/A
N/A	Any Obstructions?	N/A	N/A	Storm Grate/Utility Hazard?	N/A
	Obstruction Type			Storm Grate/Utility Type	
		N/A			N/A
			Yes	Surface Condition? (G/P)	Good
