# Access Compliance Report

## Public Rights-of-Way

### (Curb Ramps)

Intersection ID: 4999	Main Street: E_MALLARD_CREEK_CHURCH_RD	Cross Street: STONE_QUARRY_RD	Location: W
ADA ID: FBF871C974DF	Ramp Type: Perp	Initial Pass/Fail: Fail	Overall Compliance: No
Severity Score: 13.75			
Codes/Mitigation Info/Possible Solution		Field Measurements/Component Compliance

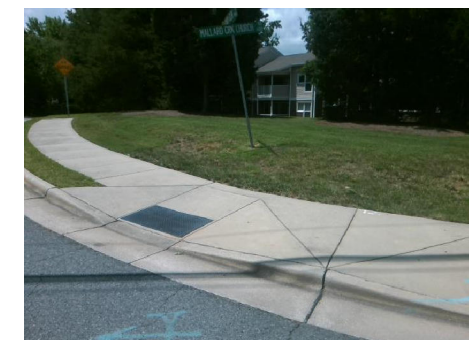
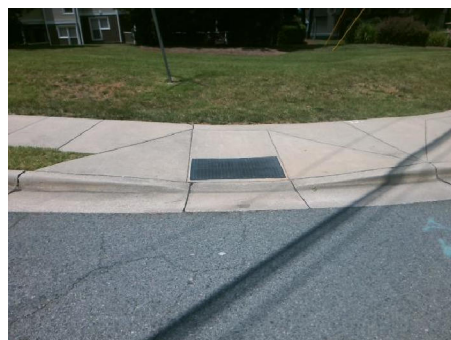
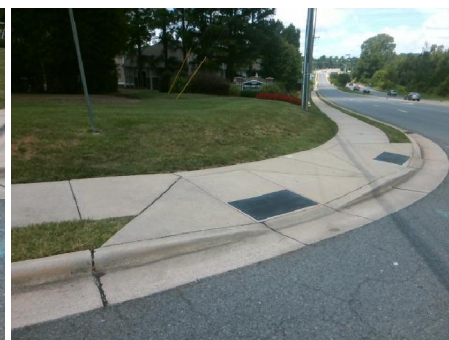
**R304.2.2, R304.5.3**

Compliance	Description	Data	Compliance	Description	Data
N/A	Ramp Length (in)	71.0	No	Ramp Slope (%)	10.3
Yes	Ramp Width (in)	48.0	No	Ramp XSlope (%)	3.5
N/A	Flare Type LT	N/A	N/A	Flare Type RT	N/A
N/A	Flare Slope LT (%)	N/A	N/A	Flare Slope RT (%)	N/A
N/A	Flare Traversable LT?	N/A	N/A	Flare Traversable RT?	N/A
N/A	Landing Length (in)	N/A	N/A	DWS Provided?	N/A
N/A	Landing Width (in)	N/A	N/A	DWS Contrast?	N/A
N/A	Landing Slope (%)	N/A	N/A	DWS Length (in)	N/A
N/A	Landing X Slope (%)	N/A	N/A	DWS Full Width?	N/A
N/A	Landing Curb? (Y/N)	N/A	N/A	DWS Offset (in)	N/A
N/A	Shared Landing?	N/A			
N/A	Gutter Ponding?	N/A	N/A	Gutter Slope (%)	N/A
N/A	Gutter Lip Ht (in)	N/A	N/A	Gutter X Slope (%)	N/A
N/A	Painted X Walk1?	No	N/A	Painted X Walk2?	N/A
	X Walk 1 Direction	To SE		X Walk 2 Direction	N/A
N/A	X Walk 1 Width (in)	N/A	N/A	X Walk 2 Width (in)	N/A
	X Walk 1 Slope (%)	1.1		X Walk 2 Slope (%)	N/A
	X Walk 1 X Slope (%)	2.7		X Walk 2 X Slope (%)	N/A

N/A	Ramp inside XWalk1?	N/A	N/A	Ramp inside XWalk2?	N/A
	Road Slope (%)	N/A	N/A	Clear Space?	N/A
	Road X Slope (%)	N/A	N/A	Clear Space to XWalk (in)	N/A
N/A	Any Obstructions?	N/A	N/A	Storm Grate/Utility Hazard?	N/A
	Obstruction Type			Storm Grate/Utility Type	
		N/A			N/A
			Yes	Surface Condition? (G/P)	Good

**Remove & Replace Entire Ramp.**

Total Cost: \$ 1850.00
