# Access Compliance Report

## Public Rights-of-Way

### (Curb Ramps)

Intersection ID: N/A	Main Street: ELEANOR_RIGBY_RD	Cross Street: MOONLIGHT_BAY_WY	Location: NE
ADA ID: FC00627792A1	Ramp Type: BlendTrans1	Initial Pass/Fail: Fail	Overall Compliance: No
		Severity Score: 1.25

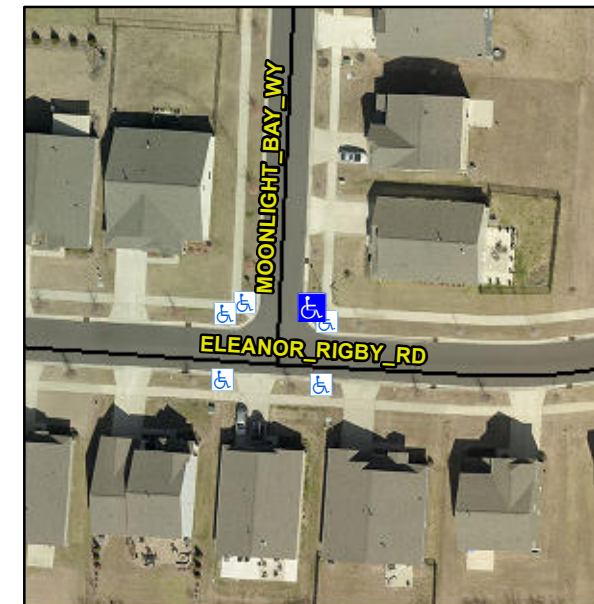
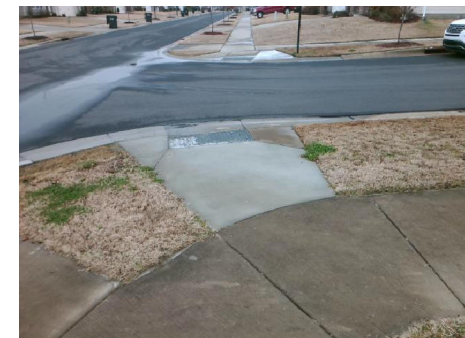
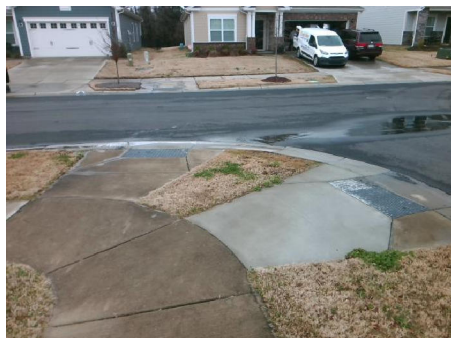
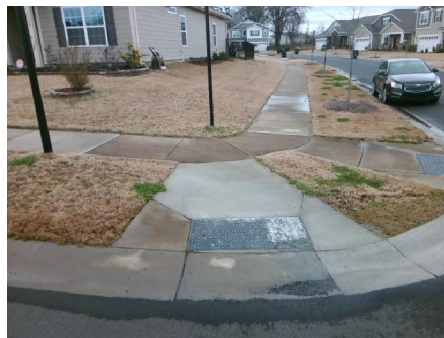
**Not Found, R304.5.3**

Compliance	Description	Data	Compliance	Description	Data
N/A	Ramp Length (in)	101.0	Yes	BlendTrans Slope (%)	3.5
Yes	Ramp Width (in)	48.0	No	BlendTrans XSlope (%)	3.1
N/A	Flare Type LT	N/A	N/A	Flare Type RT	N/A
N/A	Flare Slope LT (%)	N/A	N/A	Flare Slope RT (%)	N/A
N/A	Flare Traversable LT?	N/A	N/A	Flare Traversable RT?	N/A
N/A	Landing Length (in)	N/A	N/A	DWS Provided?	N/A
N/A	Landing Width (in)	N/A	N/A	DWS Contrast?	N/A
N/A	Landing Slope (%)	N/A	N/A	DWS Length (in)	N/A
N/A	Landing X Slope (%)	N/A	N/A	DWS Full Width?	N/A
N/A	Landing Curb? (Y/N)	N/A	N/A	DWS Offset (in)	N/A
N/A	Shared Landing?	N/A			
N/A	Gutter Ponding?	N/A	N/A	Gutter Slope (%)	N/A
N/A	Gutter Lip Ht (in)	N/A	N/A	Gutter X Slope (%)	N/A
N/A	Painted X Walk1?	No	N/A	Painted X Walk2?	N/A
	X Walk 1 Direction	To W		X Walk 2 Direction	N/A
	X Walk 1 Width (in)	N/A		X Walk 2 Width (in)	N/A
	X Walk 1 Slope (%)	3.1		X Walk 2 Slope (%)	N/A
	X Walk 1 X Slope (%)	2.3		X Walk 2 X Slope (%)	N/A

N/A	Ramp inside XWalk1?	N/A	N/A	Ramp inside XWalk2?	N/A
	Road Slope (%)	2.3		Clear Space?	N/A
	Road X Slope (%)	3.1	N/A	Clear Space to XWalk (in)	N/A
N/A	Any Obstructions?	N/A	N/A	Storm Grate/Utility Hazard?	N/A
	Obstruction Type			Storm Grate/Utility Type	
		N/A			N/A
			Yes	Surface Condition? (G/P)	Good
			No	Curb Slope (%)	7.9

**Remove & Replace Curb Ramp With Two New Directional Ramps or Equivalent.**
