# Access Compliance Report

## Public Rights-of-Way

### (Curb Ramps)

| Intersection ID: 43106 | Main Street: SHARON_RD | Cross Street: BRIARCLIFF_PL | Location: W |

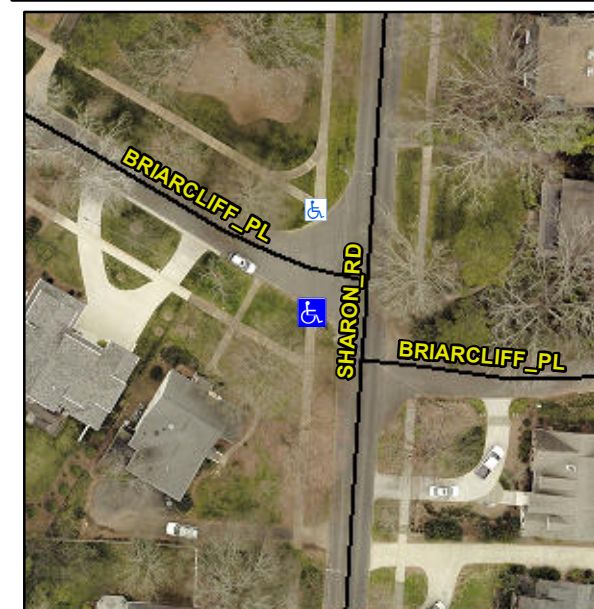
**NO CURB LINE**

**R305.1.4, R304.5.4**

| Compliance | Description | Data | Compliance | Description | Data |
|---|---|---|---|---|---|
| Yes | Landing X Slope (%) | 0.6 | No | DWS Full Width? | No |
| Yes | Gutter Ponding? | No | No | Gutter Slope (%) | 6.3 |

**Remove & Replace Detectable Warning System. Remove & Replace Gutter.**

Total Cost: \$ 1550.00
