Access Compliance Report

Public Rights-of-Way

(Curb Ramps)

Intersection ID: 16072	Main Street: MONROE_RD	Cross Street: RICHLAND_DR	Location: NE
ADA ID: FC07ADE6579D	Ramp Type: Perp	Initial Pass/Fail: Fail	Overall Compliance: No
Severity Score: 8.75			
Codes/Mitigation Info/Possible Solution		Field Measurements/Component Compliance

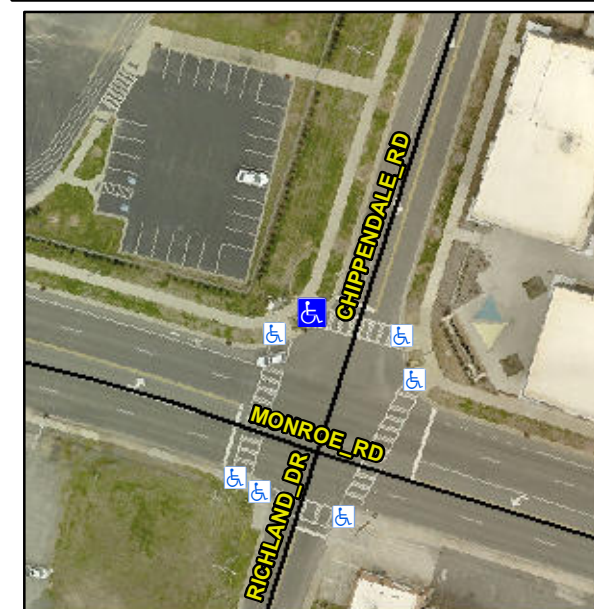
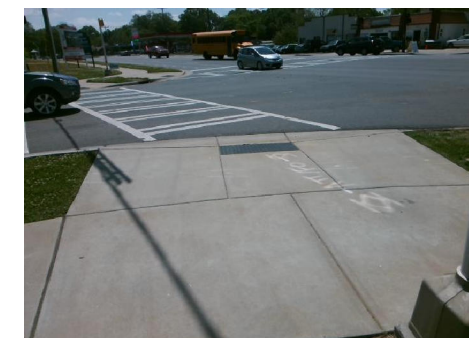
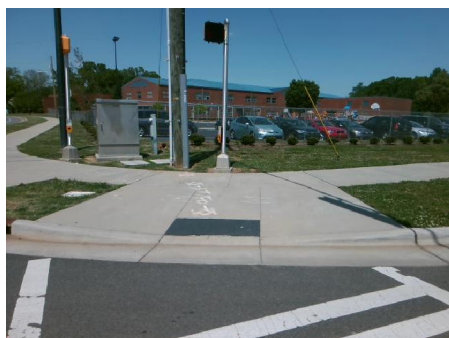
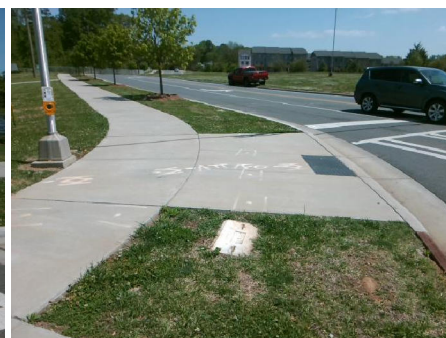
Not Found, R304.5.1

Compliance	Description	Data	Compliance	Description	Data
N/A	Ramp Length (in)	96.0	Yes	Ramp Slope (%)	5.1
No	Ramp Width (in)	46.0	Yes	Ramp XSlope (%)	1.3
N/A	Flare Type LT	N/A	N/A	Flare Type RT	N/A
N/A	Flare Slope LT (%)	N/A	N/A	Flare Slope RT (%)	N/A
N/A	Flare Traversable LT?	N/A	N/A	Flare Traversable RT?	N/A
N/A	Landing Length (in)	N/A	N/A	DWS Provided?	N/A
N/A	Landing Width (in)	N/A	N/A	DWS Contrast?	N/A
N/A	Landing Slope (%)	N/A	N/A	DWS Length (in)	N/A
N/A	Landing X Slope (%)	N/A	N/A	DWS Full Width?	N/A
N/A	Landing Curb? (Y/N)	N/A	N/A	DWS Offset (in)	N/A
N/A	Shared Landing?	N/A			
N/A	Gutter Ponding?	N/A	N/A	Gutter Slope (%)	N/A
N/A	Gutter Lip Ht (in)	N/A	N/A	Gutter X Slope (%)	N/A
N/A	Painted X Walk1?	Yes	N/A	Painted X Walk2?	N/A
	X Walk 1 Direction	To S		X Walk 2 Direction	N/A
N/A	X Walk 1 Width (in)	115.0	N/A	X Walk 2 Width (in)	N/A
	X Walk 1 Slope (%)	1.9		X Walk 2 Slope (%)	N/A
	X Walk 1 X Slope (%)	1.5		X Walk 2 X Slope (%)	N/A

N/A	Ramp inside XWalk1?	Yes	N/A	Ramp inside XWalk2?	N/A
	Road Slope (%)	N/A	N/A	Clear Space?	N/A
	Road X Slope (%)	N/A	N/A	Clear Space to XWalk (in)	N/A
N/A	Any Obstructions?	N/A	N/A	Storm Grate/Utility Hazard?	N/A
	Obstruction Type			Storm Grate/Utility Type	
		N/A			N/A
		Yes		Surface Condition? (G/P)	Good

Possible Solutions:

Remove & Replace Entire Ramp.
