Access Compliance Report

Public Rights-of-Way

(Curb Ramps)

Intersection ID: 45157	Main Street: ROBIN_TERRY_CT	Cross Street: MACVEAN_LN	Location: SW
ADA ID: FC0AFD651791	Ramp Type: PerpDiag	Initial Pass/Fail: Fail	Overall Compliance: No
Severity Score: 10			
Codes/Mitigation Info/Possible Solution		Field Measurements/Component Compliance

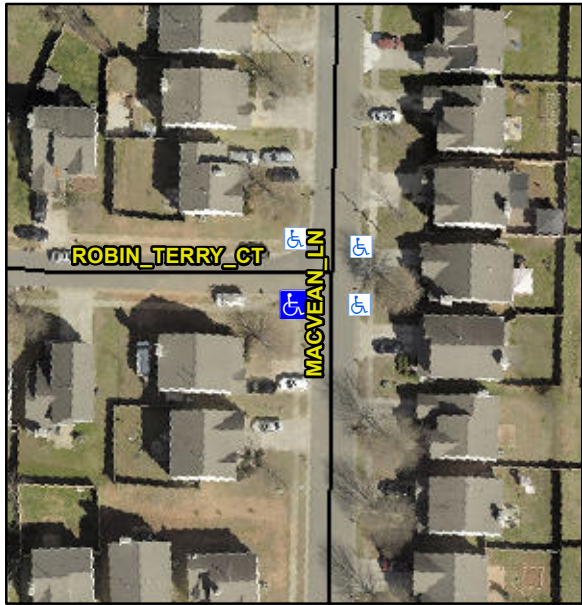
Possible Solutions:		Compliance		Description		Data	Compliance		Description		Data
	Remove & Replace Curb Ramp With Two New Directional Ramps or Equivalent.		N/A	Ramp Length (in)	48.0	Yes	Ramp Slope (%)	6.2				
			No	Ramp Width (in)	36.0	No	Ramp XSlope (%)	2.6				
			N/A	Flare Type LT	N/A	N/A	Flare Type RT	N/A				
			N/A	Flare Slope LT (%)	N/A	N/A	Flare Slope RT (%)	N/A				
			N/A	Flare Traversable LT?	N/A	N/A	Flare Traversable RT?	N/A				
			N/A	Landing Length (in)	N/A	N/A	DWS Provided?	N/A				
			N/A	Landing Width (in)	N/A	N/A	DWS Contrast?	N/A				
			N/A	Landing Slope (%)	N/A	N/A	DWS Length (in)	N/A				
			N/A	Landing X Slope (%)	N/A	N/A	DWS Full Width?	N/A				
Surveyor Notes:		N/A	N/A	Landing Curb? (Y/N)	N/A	N/A	DWS Offset (in)	N/A				
		N/A	Shared Landing?	N/A								
		N/A	Gutter Ponding?	N/A	N/A	Gutter Slope (%)	N/A					
		N/A	Gutter Lip Ht (in)	N/A	N/A	Gutter X Slope (%)	N/A					
		N/A	Painted X Walk1?	No	N/A	Painted X Walk2?	No

X Walk 1 Direction	To E		X Walk 2 Direction	To N					
		N/A	X Walk 1 Width (in)	N/A	N/A	X Walk 2 Width (in)	N/A					
			X Walk 1 Slope (%)	1.9		X Walk 2 Slope (%)	5.2					
			X Walk 1 X Slope (%)	4.8		X Walk 2 X Slope (%)	1.4					
		N/A	Ramp inside XWalk1?	N/A	N/A	Ramp inside XWalk2?	N/A					
			Road Slope (%)	1.8	N/A	Clear Space?	N/A					
			Road X Slope (%)	6.0	N/A	Clear Space to XWalk (in)	N/A					
		N/A	Any Obstructions?	N/A	N/A	Storm Grate/Utility Hazard?	N/A					
			Obstruction Type			Storm Grate/Utility Type						
					N/A		N/A					
					Yes	Surface Condition? (G/P)	Good					
							</
