# Access Compliance Report

## Public Rights-of-Way

### (Curb Ramps)

Intersection ID: 17548	Main Street: ROSWELL_AV	Cross Street: STERLING_RD	Location: NW
ADA ID: FC19921996B1	Ramp Type: PerpDiag	Initial Pass/Fail: Fail	Overall Compliance: No
		Severity Score: 22.5

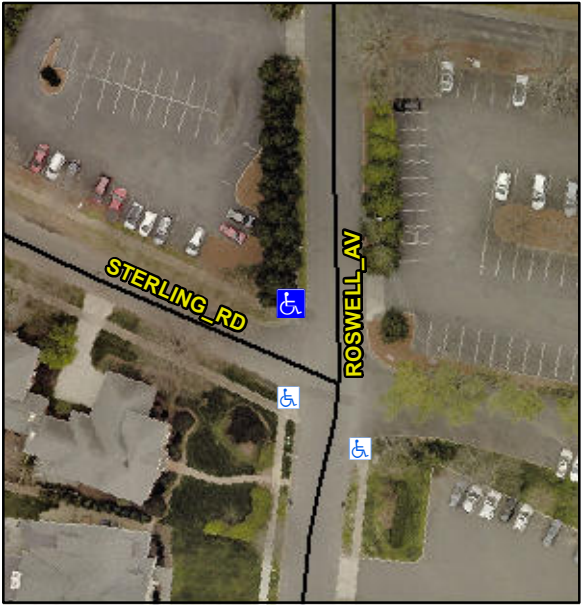
Possible Solutions:		<b>Compliance</b>	<b>Description</b>	<b>Data</b>
	<b>Remove &amp; Replace Curb Ramp With Two New Directional Ramps or Equivalent.</b>		<b>No</b>	Ramp Length (in)	<b>69.0</b>
			<b>No</b>	Ramp Width (in)	<b>46.0</b>
			<b>N/A</b>	Flare Type LT	<b>N/A</b>
			<b>N/A</b>	Flare Slope LT (%)	<b>N/A</b>
			<b>N/A</b>	Flare Traversable LT?	<b>N/A</b>
			<b>N/A</b>	Landing Length (in)	<b>N/A</b>
			<b>N/A</b>	Landing Width (in)	<b>N/A</b>
			<b>N/A</b>	Landing Slope (%)	<b>N/A</b>
			<b>N/A</b>	Landing X Slope (%)	<b>N/A</b>
<p>Surveyor Notes:</p> <p><b>N/A</b></p> <p>PROW/ADA:</p> <p><b>Not Found, R304.5.1, R304.2.2, R304.5.3</b></p>			<b>N/A</b>	Flare Type RT	<b>N/A</b>
			<b>N/A</b>	Flare Slope RT (%)	<b>N/A</b>
			<b>N/A</b>	Flare Traversable RT?	<b>N/A</b>
			<b>N/A</b>	DWS Provided?	<b>N/A</b>
			<b>N/A</b>	DWS Contrast?	<b>N/A</b>

<b>N/A</b>	DWS Length (in)	<b>N/A</b>
			<b>N/A</b>	DWS Full Width?	<b>N/A</b>
			<b>N/A</b>	DWS Offset (in)	<b>N/A</b>
			<b>N/A</b>	Gutter Ponding?	<b>N/A</b>
			<b>N/A</b>	Gutter Lip Ht (in)	<b>1.0</b>
			<b>No</b>	Painted X Walk1?	<b>No</b>
				X Walk 1 Direction	<b>To S</b>
			<b>N/A</b>	X Walk 1 Width (in)	<b>N/A</b>
			<b>6.5</b>	X Walk 1 Slope (%)	<b>5.2</b>
			<b>0.9</b>	X Walk 1 X Slope (%)	<b>3.4</b>
			<b>N/A</b>	Ramp inside XWalk1?	<b>N/A</b>
			<b>5.9</b>	Road Slope (%)	<b>N/A</b>
			<b>4.8</b>	Road X Slope (%)	<b>N/A</b>
			<b>N/A</b>	Any Obstructions?	<b>N/A</b>
				Obstruction Type	
Total Cost: \$ 3200.00			<b>N/A</b>	Storm Grate/Utility Hazard?	<b>N/A</b>
			<b>N/A</b>	Storm Grate/Utility Type	
			<b>Yes</b>	Surface Condition? (G/P)	<b>Good</b>
