# Access Compliance Report

## Public Rights-of-Way

### (Curb Ramps)

Intersection ID: 13156	Main Street: S_TRYON_ST	Cross Street: W_CARSON_BV	Location: N
ADA ID: FC334A177406	Ramp Type: PerpDiag	Initial Pass/Fail: Fail	Overall Compliance: No
			Severity Score: 21.25

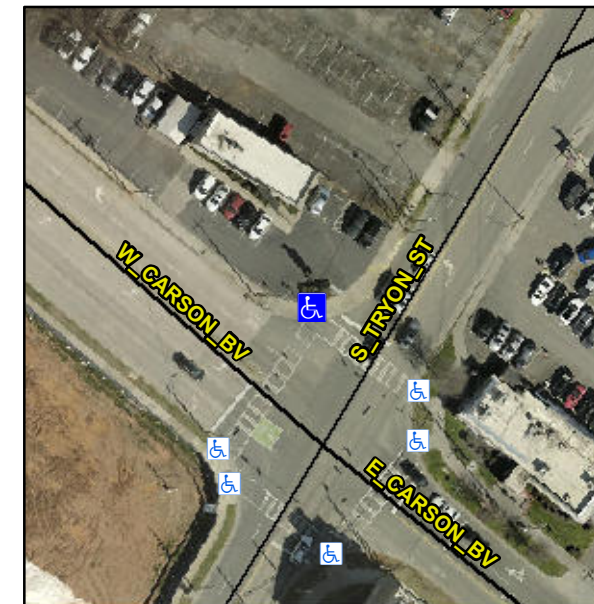
**Not Found, R304.5.1, R304.2.2**

Compliance	Description	Data	Compliance	Description	Data
N/A	Ramp Length (in)	85.0	No	Ramp Slope (%)	9.0
No	Ramp Width (in)	40.5	Yes	Ramp XSlope (%)	0.5
N/A	Flare Type LT	N/A	N/A	Flare Type RT	N/A
N/A	Flare Slope LT (%)	N/A	N/A	Flare Slope RT (%)	N/A
N/A	Flare Traversable LT?	N/A	N/A	Flare Traversable RT?	N/A
N/A	Landing Length (in)	N/A	N/A	DWS Provided?	N/A
N/A	Landing Width (in)	N/A	N/A	DWS Contrast?	N/A
N/A	Landing Slope (%)	N/A	N/A	DWS Length (in)	N/A
N/A	Landing X Slope (%)	N/A	N/A	DWS Full Width?	N/A
N/A	Landing Curb? (Y/N)	N/A	N/A	DWS Offset (in)	N/A
N/A	Shared Landing?	N/A			
N/A	Gutter Ponding?	N/A	N/A	Gutter Slope (%)	N/A
N/A	Gutter Lip Ht (in)	N/A	N/A	Gutter X Slope (%)	N/A
N/A	Painted X Walk1?	Yes	N/A	Painted X Walk2?	Yes
	X Walk 1 Direction	To SW		X Walk 2 Direction	To SE
N/A	X Walk 1 Width (in)	100.0	N/A	X Walk 2 Width (in)	111.0
	X Walk 1 Slope (%)	2.0		X Walk 2 Slope (%)	0.6
	X Walk 1 X Slope (%)	0.9		X Walk 2 X Slope (%)	0.0

N/A	Ramp inside XWalk1?	Yes	N/A	Ramp inside XWalk2?	Yes
	Road Slope (%)	1.5	N/A	Clear Space?	N/A
	Road X Slope (%)	1.6	N/A	Clear Space to XWalk (in)	N/A
N/A	Any Obstructions?	N/A	N/A	Storm Grate/Utility Hazard?	N/A
	Obstruction Type			Storm Grate/Utility Type	
		N/A			N/A
		Yes		Surface Condition? (G/P)	Good

**Remove & Replace Curb Ramp With Two New Directional Ramps or Equivalent.**
