Access Compliance Report

Public Rights-of-Way

(Curb Ramps)

Intersection ID: 19257	Main Street: BEAM_RD	Cross Street: S_TRYON_ST	Location: NW
ADA ID: FC344301AE80	Ramp Type: PerpDiag	Initial Pass/Fail: Fail	Overall Compliance: No
		Severity Score: 22.5

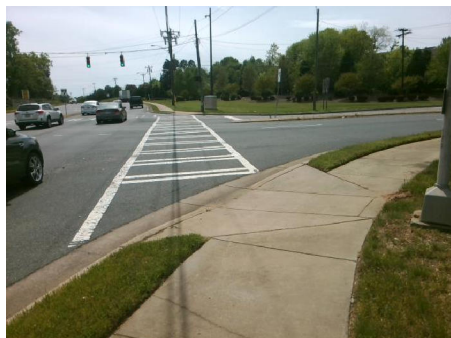
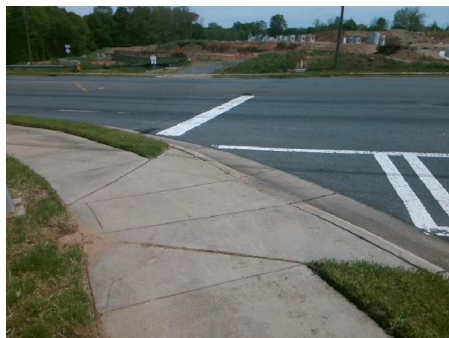
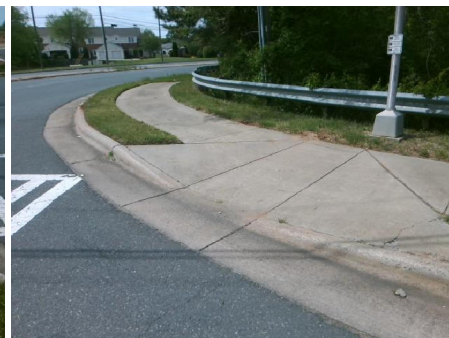
Compliance	Description	Data	Compliance	Description	Data
N/A	Ramp Length (in)	90.0	No	Ramp Slope (%)	9.1
No	Ramp Width (in)	45.0	Yes	Ramp XSlope (%)	3.1
N/A	Flare Type LT	N/A	N/A	Flare Type RT	N/A
N/A	Flare Slope LT (%)	N/A	N/A	Flare Slope RT (%)	N/A
N/A	Flare Traversable LT?	N/A	N/A	Flare Traversable RT?	N/A
N/A	Landing Length (in)	N/A	N/A	DWS Provided?	N/A
N/A	Landing Width (in)	N/A	N/A	DWS Contrast?	N/A
N/A	Landing Slope (%)	N/A	N/A	DWS Length (in)	N/A
N/A	Landing X Slope (%)	N/A	N/A	DWS Full Width?	N/A
N/A	Landing Curb? (Y/N)	N/A	N/A	DWS Offset (in)	N/A
N/A	Shared Landing?	N/A			
N/A	Gutter Ponding?	N/A	N/A	Gutter Slope (%)	N/A
N/A	Gutter Lip Ht (in)	N/A	N/A	Gutter X Slope (%)	N/A
N/A	Painted X Walk1?	Yes	N/A	Painted X Walk2?	No
	X Walk 1 Direction	To S		X Walk 2 Direction	To E
N/A	X Walk 1 Width (in)	113.0	N/A	X Walk 2 Width (in)	N/A
	X Walk 1 Slope (%)	3.8		X Walk 2 Slope (%)	0.8
	X Walk 1 X Slope (%)	1.3		X Walk 2 X Slope (%)	3.3

N/A	Ramp inside XWalk1?	Yes	N/A	Ramp inside XWalk2?	N/A
	Road Slope (%)	3.7	N/A	Clear Space?	N/A
	Road X Slope (%)	2.4	N/A	Clear Space to XWalk (in)	N/A
N/A	Any Obstructions?	N/A	N/A	Storm Grate/Utility Hazard?	N/A
	Obstruction Type			Storm Grate/Utility Type	
		N/A			N/A
		Yes		Surface Condition? (G/P)	Good

Remove & Replace Curb Ramp With Two New Directional Ramps or Equivalent.
