## Access Compliance Report Public Rights-of-Way (Curb Ramps)

Intersection ID: 29153 Main Street: BRIAR\_ROSE\_CT Cross Street: HIGHLAND\_PARK\_DR Location: N

ADA ID: FC54765C2910 Ramp Type: PerpDiag Initial Pass/Fail: Pass Overall Compliance: No Severity Score: 7.75

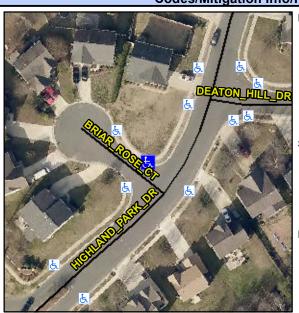
Compliance Description		Data	Data Compliance Description		Data
N/A	Ramp Length (in)	47.0	Yes	Ramp Slope (%)	6.0
Yes	Ramp Width (in)	48.0	No	Ramp XSlope (%)	2.2
N/A	Flare Type LT	Sloped	N/A	Flare Type RT	N/A
N/A	Flare Slope LT (%)	4.6	Yes	Flare Slope RT (%)	9.8
N/A	Flare Traversable LT?	Yes	N/A	Flare Traversable RT?	Yes
No	Landing Length (in)	47.0	Yes	DWS Provided?	Yes
Yes	Landing Width (in)	48.0	Yes	DWS Contrast?	Yes
Yes	Landing Slope (%)	0.8	No	DWS Length (in)	23.0
No	Landing X Slope (%)	2.8	Yes	DWS Full Width?	Yes
N/A	Landing Curb? (Y/N)	No	No	DWS Offset (in)	2.5
N/A	Shared Landing?	No			
Yes	Gutter Ponding?	No	Yes	Gutter Slope (%)	2.9
No	Gutter Lip Ht (in)	0.5	Yes	Gutter X Slope (%)	0.7
N/A	Painted X Walk1?	No	N/A	Painted X Walk2?	No
	X Walk 1 Direction	To SW		X Walk 2 Direction	To SE
N/A	X Walk 1 Width (in)	N/A	N/A	X Walk 2 Width (in)	N/A
	X Walk 1 Slope (%)	0.9		X Walk 2 Slope (%)	1.2
	X Walk 1 X Slope (%)	15.0		X Walk 2 X Slope (%)	0.9

N/A	Ramp inside XWalk1?	N/A	N/A	Ramp inside XWalk2?	N/A
	Road Slope (%)	1.9	N/A	Clear Space?	Yes
	Road X Slope (%)	0.9	N/A	Clear Space to XWalk (in)	N/A
Yes	Any Obstructions?	No	Yes	Storm Grate/Utility Hazard?	No
	Obstruction Type		l	Storm Grate/Utility Type	
		N/A			N/A
			l

BRIAR ROSE CT StopSign HIGHLAND PARK DR None Possible Solutions:

Remove & Replace Curb Ramp With Two New Directional Ramps or Equivalent. Grind Gutter Lip.
