## Access Compliance Report Public Rights-of-Way (Curb Ramps)

Intersection ID: 12013 Main Street: FREEDOM\_DR Cross Street: W\_MOREHEAD\_ST Location: SW

ADA ID: FC5C3DC837F7 Ramp Type: Perp Initial Pass/Fail: Fail Overall Compliance: No Severity Score: 8.75

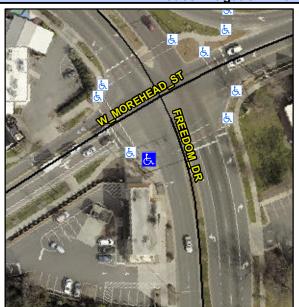
/Possible Solution		Field Measurements/Component Compliance							
Possible Solutions:		Compli	ance Description	Data	Compliance	Description	Data		
Remove & Replace Entire	Ramp.	N/A	Ramp Length (in)	72.0	<b>Yes</b> Ran	np Slope (%)	8.0

-	No	Ramp Width (in)	47.5	<b>Yes</b> Ran	np XSlope (%)	2.0		
		N/A	Flare Type LT	N/A	N/A Flar	e Type RT	N/A		
		N/A	Flare Slope LT (%)	N/A	N/A Flar	e Slope RT (%)	N/A		
		N/A	Flare Traversable LT?	N/A	N/A Flar	e Traversable RT?	N/A		
V .		N/A	Landing Length (in)	N/A	<b>N/A</b> DW	S Provided?	N/A		
Surveyor Notes:		N/A	Landing Width (in)	N/A	<b>N/A</b> DW	S Contrast?	N/A		
N/A		N/A	Landing Slope (%)	N/A	<b>N/A</b> DW	S Length (in)	N/A		
		N/A	Landing X Slope (%)	N/A	N/A DW	S Full Width?	N/A		
		N/A	Landing Curb? (Y/N)	N/A	<b>N/A</b> DW	S Offset (in)	N/A		
		N/A	Shared Landing?	N/A					
PROW/ADA:		N/A	Gutter Ponding?	N/A	<b>N/A</b> Gut	ter Slope (%)	N/A		
Not Found, R304.5.1		N/A	Gutter Lip Ht (in)	N/A	<b>N/A</b> Gut	ter X Slope (%)	N/A		
·		N/A	Painted X Walk1?	Yes	<b>N/A</b> Pair	nted X Walk2?	N/A		
			X Walk 1 Direction	To E	ΧW	alk 2 Direction	N/A		
		N/A	X Walk 1 Width (in)	114.0	N/A X W	alk 2 Width (in)	N/A

X Walk 1 Slope (%)	2.5	ΧW	/alk 2 Slope (%)	N/A		
			X Walk 1 X Slope (%)	2.5	ΧW	/alk 2 X Slope (%)	N/A		
		N/A	Ramp inside XWalk1?	Yes	<b>N/A</b> Rar	np inside XWalk2?	N/A		
			Road Slope (%)	N/A	N/A Cle	ar Space?	N/A		
			Road X Slope (%)	N/A	N/A Cle	ar Space to XWalk (in)	N/A		
		N/A	Any Obstructions?	N/A	N/A Sto	m Grate/Utility Hazard?	N/A		
Total Cost:	\$ 1850.00		Obstruction Type		Sto	m Grate/Utility Type			
				N/A			N/A
