# Access Compliance Report

## Public Rights-of-Way

| Intersection ID: 10955 | Main Street: ROBINSON_CHURCH_RD | Cross Street: BRAWLEY_LN | Location: NE |
| ADA ID: FC60E61A92E9 | Ramp Type: Perp | Initial Pass/Fail: Fail | Overall Compliance: No |

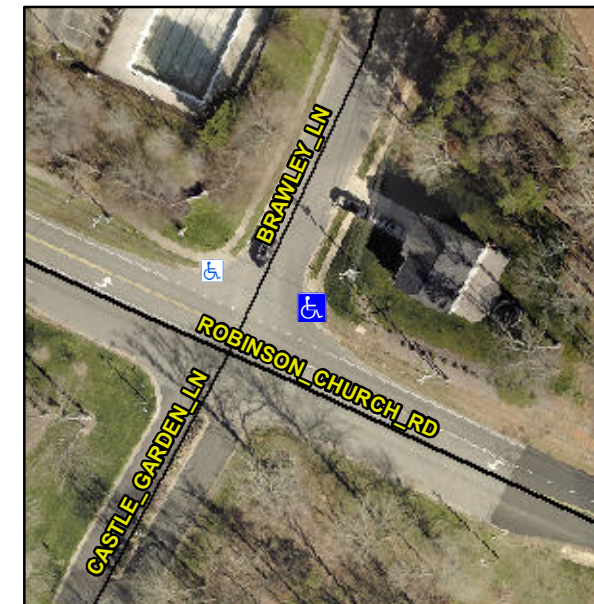
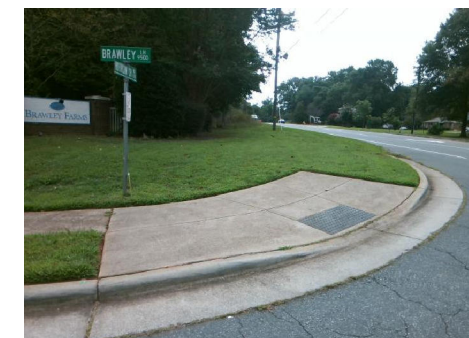
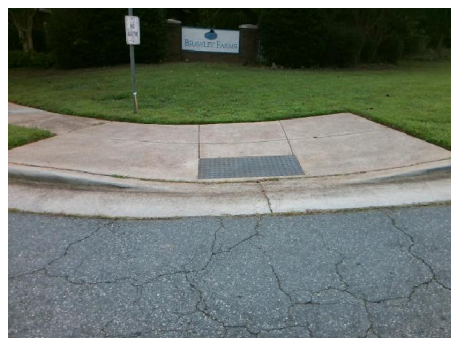
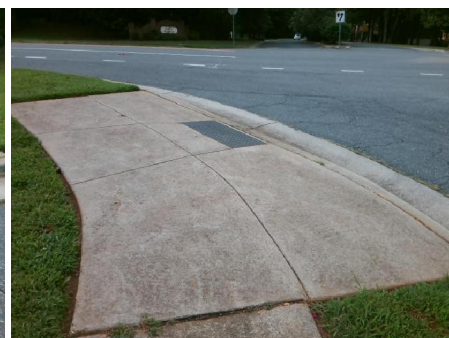
| Severity Score: 46.25 | | | |

**R304.5.1, R304.2.2, R304.5.3**

| Compliance | Description | Data | Compliance | Description | Data |
|---|---|---|---|---|---|
| N/A | Ramp Length (in) | 48.5 | No | Ramp Slope (%) | 8.4 |
| No | Ramp Width (in) | 47.5 | No | Ramp XSlope (%) | 7.1 |

**Remove & Replace Entire Ramp.**
