Access Compliance Report

Public Rights-of-Way

(Curb Ramps)

Intersection ID: 10022370	Main Street: CAMILLA_DR	Cross Street: N/A	Location: SE
ADA ID: FC6131BB3F32	Ramp Type: ParaDiag	Initial Pass/Fail: Fail	Overall Compliance: No
Codes/Mitigation Info/Possible Solution		Field Measurements/Component Compliance	
Severity Score: 22.5

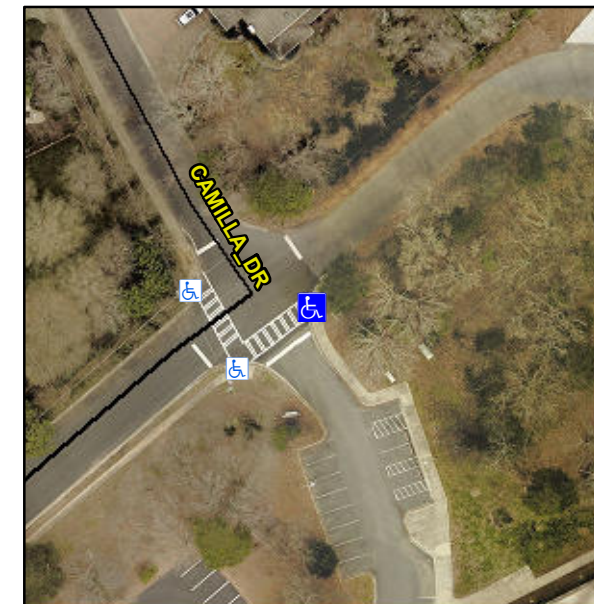
LT RP < 5%

Compliance	Description	Data	Compliance	Description	Data
N/A	Ramp Length LT (in)	48.0	N/A	Ramp Length RT (in)	55.0
No	Ramp Width LT (in)	36.0	No	Ramp Width RT (in)	36.0
Yes	Ramp Slope LT (%)	0.2	No	Ramp Slope RT (%)	11.2
Yes	Ramp XSlope LT (%)	0.9	No	Ramp XSlope RT (%)	2.5
N/A	Landing Length (in)	N/A	N/A	DWS Provided?	N/A
N/A	Landing Width (in)	N/A	N/A	DWS Contrast?	N/A
N/A	Landing Slope (%)	N/A	N/A	DWS Length (in)	N/A
N/A	Landing X Slope (%)	N/A	N/A	DWS Full Width?	N/A
N/A	Landing Curb? (Y/N)	N/A	N/A	DWS Offset (in)	N/A
N/A	Shared Landing?	N/A			
N/A	Gutter Ponding?	N/A	N/A	Gutter Slope (%)	N/A
N/A	Gutter Lip Ht (in)	N/A	N/A	Gutter X Slope (%)	N/A
N/A	Painted X Walk1?	No	N/A	Painted X Walk2?	Yes
	X Walk 1 Direction	To SE		X Walk 2 Direction	To NW
N/A	X Walk 1 Width (in)	N/A	N/A	X Walk 2 Width (in)	111.0
	X Walk 1 Slope (%)	0.2		X Walk 2 Slope (%)	6.0
	X Walk 1 X Slope (%)	6.4		X Walk 2 X Slope (%)	0.8
N/A	Ramp inside XWalk1?	N/A	N/A	Ramp inside XWalk2?	Yes

Road Slope (%)	5.3	N/A	Clear Space?	N/A
	Road X Slope (%)	4.4	N/A	Clear Space to XWalk (in)	N/A
N/A	Any Obstructions?	N/A	N/A	Storm Grate/Utility Hazard?	N/A
	Obstruction Type			Storm Grate/Utility Type	
		N/A			N/A
			Yes	Surface Condition? (G/P)	Good
			N/A	Curb Slope (%)	9.2

Possible Solutions:

Remove & Replace Curb Ramp With Two New Directional Ramps or Equivalent.
