Access Compliance Report

Public Rights-of-Way

(Curb Ramps)

Intersection ID: 11550	Main Street: JOY_ST	Cross Street: WILSON_AV	Location: NE
ADA ID: FC655078CCFB	Ramp Type: Perp	Initial Pass/Fail: Fail	Overall Compliance: No
			Severity Score: 26.25

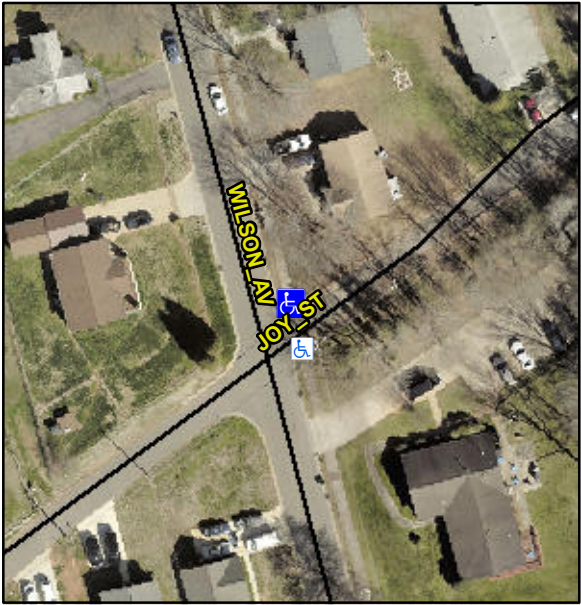
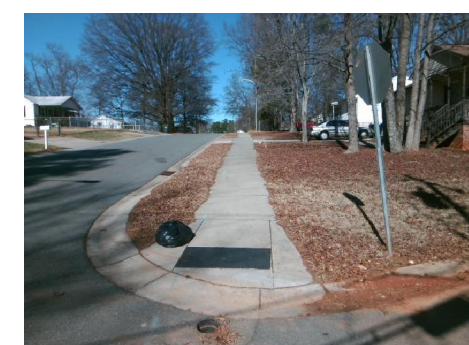
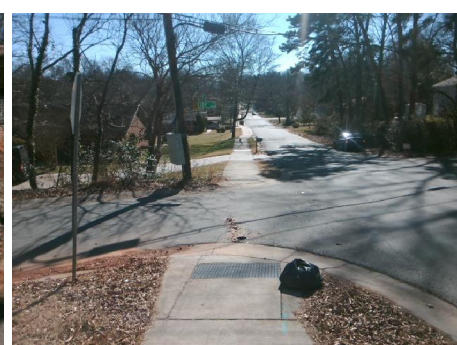
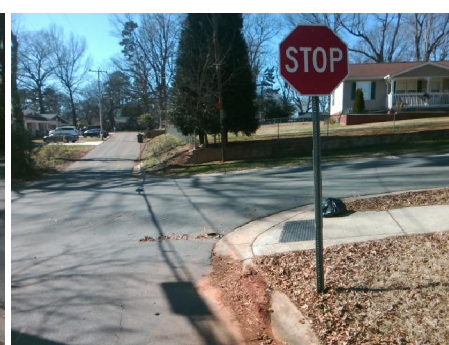
Possible Solutions:		Compliance	Description	Data
	Remove & Replace Entire Ramp.		No	Ramp Length (in)	86.5
			Yes	Ramp Width (in)	48.5
			N/A	Flare Type LT	N/A
			N/A	Flare Slope LT (%)	N/A
			N/A	Flare Traversable LT?	N/A
			N/A	Landing Length (in)	N/A
			N/A	Landing Width (in)	N/A
			N/A	Landing Slope (%)	N/A
			N/A	Landing X Slope (%)	N/A
<p>Surveyor Notes:</p> <p>N/A</p> <p>PROW/ADA:</p> <p>Not Found, R304.2.2, R304.5.3</p>			N/A	Flare Type RT	N/A
			N/A	Flare Slope RT (%)	N/A
			N/A	Flare Traversable RT?	N/A
			N/A	DWS Provided?	N/A
			N/A	DWS Contrast?	N/A
			N/A	DWS Length (in)	N/A
			N/A	DWS Full Width?	N/A
			N/A	DWS Offset (in)	N/A
			N/A	Gutter Ponding?	N/A
			N/A	Gutter Lip Ht (in)	N/A
			No	Painted X Walk1?	N/A
			To S	X Walk 2 Direction	N/A
			N/A	X Walk 2 Width (in)	N/A

6.4	X Walk 2 Slope (%)	N/A
			2.0	X Walk 2 X Slope (%)	N/A
			N/A	Ramp inside XWalk1?	N/A
			N/A	Ramp inside XWalk2?	N/A
			N/A	Clear Space?	N/A
			N/A	Clear Space to XWalk (in)	N/A
			N/A	Storm Grate/Utility Hazard?	N/A
			N/A	Storm Grate/Utility Type	N/A
			Yes	Surface Condition? (G/P)	Good
Total Cost:		\$ 1850.00
