Access Compliance Report

Public Rights-of-Way

(Curb Ramps)

Intersection ID: 14294	Main Street: EAST_BV	Cross Street: EUCLID_AV	Location: SW
ADA ID: FC6DAC924547	Ramp Type: Directional1	Initial Pass/Fail: Fail	Overall Compliance: No
		Severity Score: 60

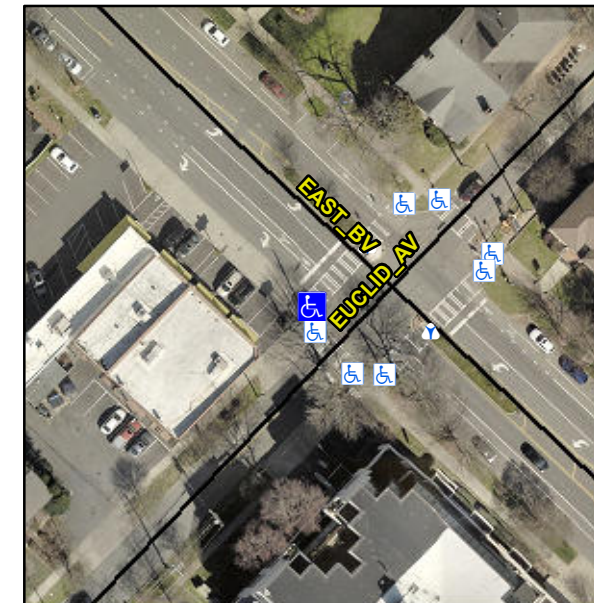
Compliance	Description	Data	Compliance	Description	Data
N/A	Ramp Length (in)	56.0	N/A	Grade Break?	N/A
No	Ramp Width (in)	30.0	N/A	Grade Break Slope (%)	0.0
No	Ramp Slope (%)	9.0	N/A	Grade Break XSlope (%)	0.0
No	Ramp XSlope (%)	5.8			
N/A	Flare Type LT	N/A	N/A	Flare Type RT	N/A
N/A	Flare Slope LT (%)	N/A	N/A	Flare Slope RT (%)	0.0
N/A	Flare Traversable LT?	N/A	N/A	Flare Traversable RT?	N/A
N/A	Landing Length (in)	0.0	N/A	DWS Provided?	N/A
N/A	Landing Width (in)	0.0	N/A	DWS Contrast?	N/A
N/A	Landing Slope (%)	0.0	N/A	DWS Length (in)	N/A
N/A	Landing X Slope (%)	0.0	N/A	DWS Full Width?	N/A
N/A	Landing Curb? (Y/N)	N/A	N/A	DWS Offset LT (in)	N/A
N/A	Shared Landing?	N/A	N/A	DWS Offset RT (in)	N/A
N/A	Gutter Ponding?	0.0	N/A	Gutter Slope (%)	N/A
N/A	Gutter Lip Ht (in)	0.0	N/A	Gutter X Slope (%)	N/A
N/A	Painted X Walk1?	Yes		Road Slope (%)	9.0
	X Walk 1 Direction	To NE		Road X Slope (%)	0.2
	X Walk 1 Width (in)	113.0		Clear Space?	N/A

X Walk 1 Slope (%)	9.0	N/A	Clear Space to XWalk (in)	N/A
	X Walk 1 X Slope (%)	0.2	N/A	Storm Grate/Utility Hazard?	N/A
N/A	Ramp inside XWalk1?	Yes		Storm Grate/Utility Type	
N/A	Any Obstructions?	N/A			N/A
	Obstruction Type		Yes	Surface Condition? (G/P)	Good
			N/A	Curb Slope (%)	2.9

Remove & Replace Entire Ramp.
