Access Compliance Report Public Rights-of-Way (Curb Ramps)

Intersection ID: 10031236Main Street:MARSH_RDCross Street:N/ALocation:NWADA ID: FC6E451EC8F5Ramp Type:PerpDiagInitial Pass/Fail:FailOverall Compliance:NoSeverity Score:22.5

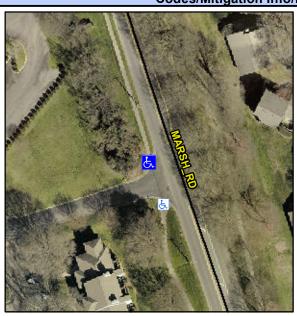
Not Found, R304.5.1, R304.2.2, R304.5.3

Comp	oliance Description	Data	Comp	liance	Description	Data
N/A	Ramp Length (in)	99.0	No	Ramp	Slope (%)	8.7
No	Ramp Width (in)	46.0	No	Ramp	XSlope (%)	3.8
N/A	Flare Type LT	N/A	N/A	Flare	Type RT	N/A
N/A	Flare Slope LT (%)	N/A	N/A	Flare	Slope RT (%)	N/A
N/A	Flare Traversable LT?	N/A	N/A	Flare	Traversable RT?	N/A
N/A	Landing Length (in)	N/A	N/A	DWS	Provided?	N/A
N/A	Landing Width (in)	N/A	N/A	DWS	Contrast?	N/A
N/A	Landing Slope (%)	N/A	N/A	DWS	Length (in)	N/A
N/A	Landing X Slope (%)	N/A	N/A	DWS	Full Width?	N/A
N/A	Landing Curb? (Y/N)	N/A	N/A	DWS	Offset (in)	N/A
N/A	Shared Landing?	N/A				
N/A	Gutter Ponding?	N/A	N/A	Gutte	r Slope (%)	N/A
N/A	Gutter Lip Ht (in)	N/A	N/A	Gutte	r X Slope (%)	N/A
N/A	Painted X Walk1?	No	N/A	Painte	ed X Walk2?	No
	X Walk 1 Direction	To S		X Wal	lk 2 Direction	To E
N/A	X Walk 1 Width (in)	N/A	N/A	X Wal	lk 2 Width (in)	N/A
	X Walk 1 Slope (%)	1.7		X Wal	lk 2 Slope (%)	5.2
	X Walk 1 X Slope (%)	3.4		X Wal	lk 2 X Slope (%)	1.3

N/A	Ramp inside XWalk1?	N/A	N/A	Ramp	inside XWalk2?	N/A
	Road Slope (%)	1.2	N/A	Clear	Space?	N/A
	Road X Slope (%)	4.2	N/A	Clear	Space to XWalk (in)	N/A
N/A	Any Obstructions?	N/A	N/A	Storm	Grate/Utility Hazard?	N/A
	Obstruction Type			Storm	Grate/Utility Type	
		N/A				N/A
			Yes	Surfac	ce Condition? (G/P)	Good

ENTRANCE StopSign MARSH RD None Remove & Replace Curb Ramp With Two New Directional Ramps or Equivalent.
