Access Compliance Report

Public Rights-of-Way

(Curb Ramps)

Intersection ID: 13947	Main Street: CHERRY_ST	Cross Street: CHARLOTTETOWNE_AV	Location: SW
ADA ID: FC72EE857220	Ramp Type: Perp	Initial Pass/Fail: Fail	Overall Compliance: No
Severity Score: 25			
Codes/Mitigation Info/Possible Solution		Field Measurements/Component Compliance

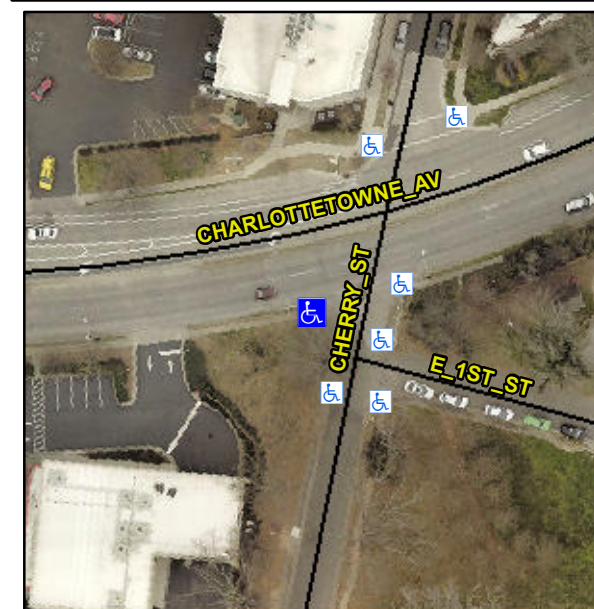
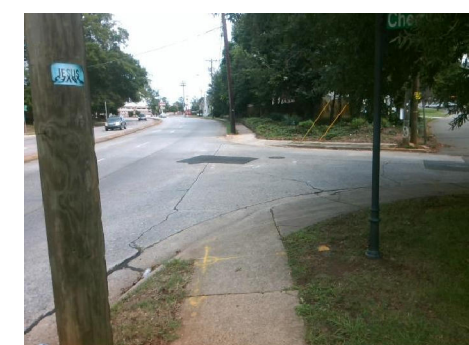
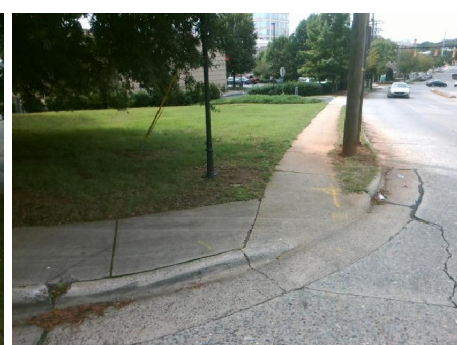
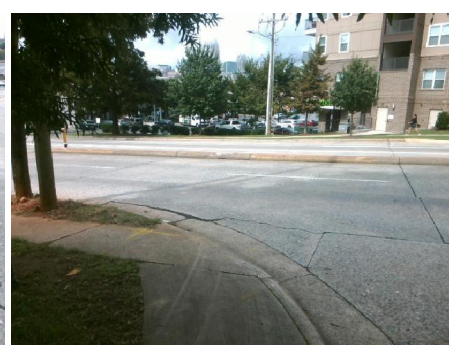
Not Found, R304.2.2, R304.5.3

Compliance	Description	Data	Compliance	Description	Data
N/A	Ramp Length (in)	48.0	No	Ramp Slope (%)	11.3
Yes	Ramp Width (in)	48.0	No	Ramp XSlope (%)	5.7
N/A	Flare Type LT	N/A	N/A	Flare Type RT	N/A
N/A	Flare Slope LT (%)	N/A	N/A	Flare Slope RT (%)	N/A
N/A	Flare Traversable LT?	N/A	N/A	Flare Traversable RT?	N/A
N/A	Landing Length (in)	N/A	N/A	DWS Provided?	N/A
N/A	Landing Width (in)	N/A	N/A	DWS Contrast?	N/A
N/A	Landing Slope (%)	N/A	N/A	DWS Length (in)	N/A
N/A	Landing X Slope (%)	N/A	N/A	DWS Full Width?	N/A
N/A	Landing Curb? (Y/N)	N/A	N/A	DWS Offset (in)	N/A
N/A	Shared Landing?	N/A			
N/A	Gutter Ponding?	N/A	N/A	Gutter Slope (%)	N/A
N/A	Gutter Lip Ht (in)	N/A	N/A	Gutter X Slope (%)	N/A
N/A	Painted X Walk1?	No	N/A	Painted X Walk2?	N/A
	X Walk 1 Direction	To E		X Walk 2 Direction	N/A
N/A	X Walk 1 Width (in)	N/A	N/A	X Walk 2 Width (in)	N/A
	X Walk 1 Slope (%)	5.8		X Walk 2 Slope (%)	N/A
	X Walk 1 X Slope (%)	2.3		X Walk 2 X Slope (%)	N/A

N/A	Ramp inside XWalk1?	N/A	N/A	Ramp inside XWalk2?	N/A
	Road Slope (%)	N/A	N/A	Clear Space?	N/A
	Road X Slope (%)	N/A	N/A	Clear Space to XWalk (in)	N/A
N/A	Any Obstructions?	N/A	N/A	Storm Grate/Utility Hazard?	N/A
	Obstruction Type			Storm Grate/Utility Type	
		N/A			N/A
		Yes		Surface Condition? (G/P)	Good

Remove & Replace Entire Ramp.

Total Cost: \$ 1850.00
