| Intersection ID: 18365 | Main Street: TRYON_ST | Cross Street: TYVOLA_RD | Location: | NW |
| ADA ID: FC756627090A | Ramp Type: Perp | Initial Pass/Fail: Pass | Overall Compliance: No | Severity Score: 20.25 |

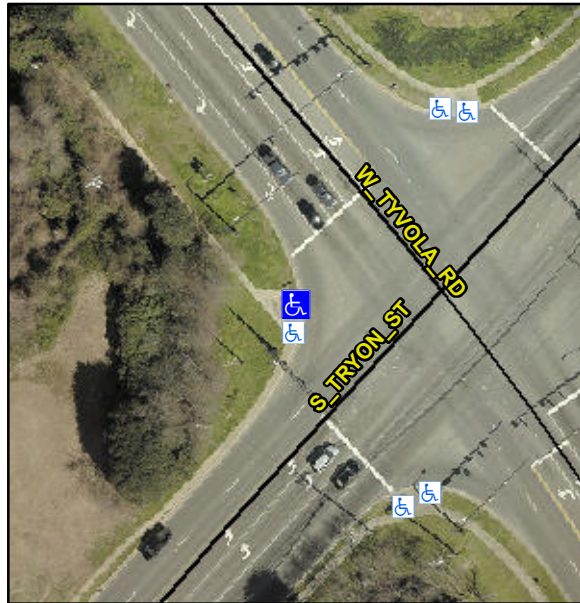
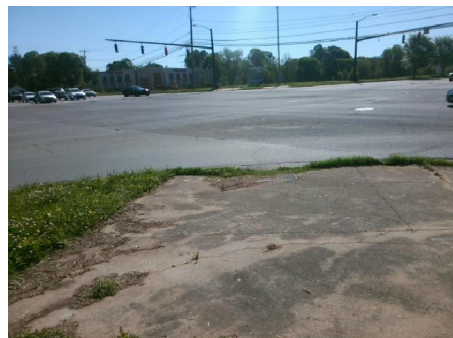
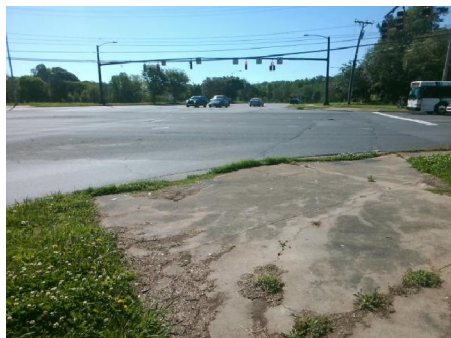
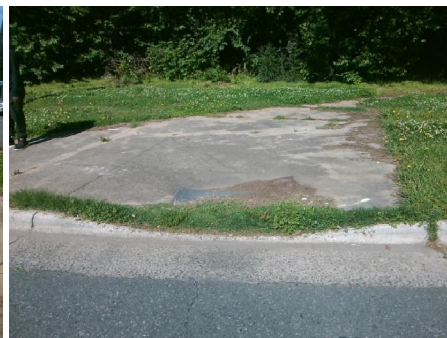
**Not Found, R304.5.3, R305.2,  
R302.7.2, R304.5.4**

| Compliance | Description | Data | Compliance | Description | Data |
|---|---|---|---|---|---|
| Yes | Ramp Width (in) | 48.0 | No | Ramp XSlope (%) | 3.6 |
| N/A | Landing Curb? (Y/N) | No | No | DWS Offset (in) | 6.5 |
| Yes | Gutter Ponding? | No | No | Gutter Slope (%) | 5.7 |
| No | Gutter Lip Ht (in) | 1.0 | Yes | Gutter X Slope (%) | 0.1 |

**Remove & Replace Entire Ramp.  
Remove & Replace Gutter.**

Total Cost: \$ 2600.00
