Access Compliance Report

Public Rights-of-Way

(Curb Ramps)

Intersection ID: 19402	Main Street: GRETNA_GREEN_DR	Cross Street: S_TRYON_ST	Location: NE
ADA ID: FC9CFC1A8B6F	Ramp Type: PerpDiag	Initial Pass/Fail: Fail	Overall Compliance: No
Severity Score: 13.75			
Codes/Mitigation Info/Possible Solution		Field Measurements/Component Compliance

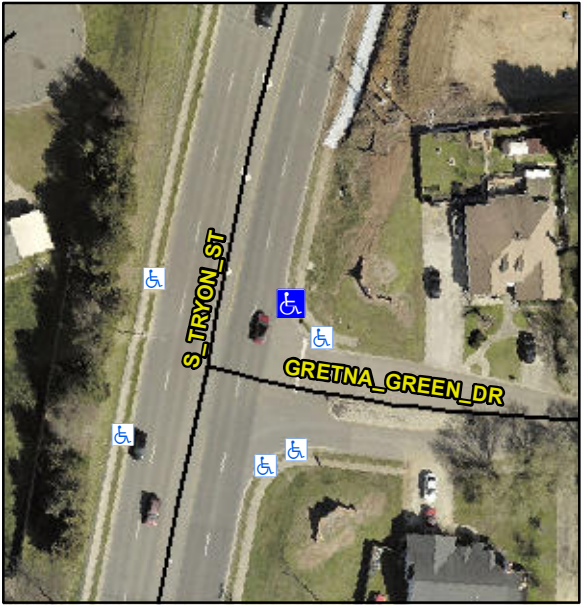
N/A	Painted X Walk1?	No	N/A	Painted X Walk2?	No
				X Walk 1 Direction	To W		X Walk 2 Direction	To S
			N/A	X Walk 1 Width (in)	N/A	N/A	X Walk 2 Width (in)	N/A
				X Walk 1 Slope (%)	9.8		X Walk 2 Slope (%)	0.8
				X Walk 1 X Slope (%)	0.5		X Walk 2 X Slope (%)	6.7
			N/A	Ramp inside XWalk1?	N/A	N/A	Ramp inside XWalk2?	N/A
				Road Slope (%)	3.9	N/A	Clear Space?	N/A
				Road X Slope (%)	7.7	N/A	Clear Space to XWalk (in)	N/A
			N/A	Any Obstructions?	N/A	N/A	Storm Grate/Utility Hazard?	N/A
				Obstruction Type			Storm Grate/Utility Type	
						N/A		N/A
						Yes	Surface Condition? (G/P)	Good

Possible Solutions:		Compliance	Description	Data	Compliance	Description	Data
	Remove & Replace Curb Ramp With Two New Directional Ramps or Equivalent.		N/A	Ramp Length (in)	90.0	No	Ramp Slope (%)	8.9
<p>Surveyor Notes:</p> <p>N/A</p> <p>PROW/ADA:</p> <p>Not Found, R304.2.2, R304.5.3</p>			Yes	Ramp Width (in)	49.0	No	Ramp XSlope (%)	2.8
			N/A	Flare Type LT	N/A	N/A	Flare Type RT	N/A
			N/A	Flare Slope LT (%)	N/A	N/A	Flare Slope RT (%)	N/A
			N/A	Flare Traversable LT?	N/A	N/A	Flare Traversable RT?	N/A
			N/A	Landing Length (in)	N/A	N/A	DWS Provided?	N/A
			N/A	Landing Width (in)	N/A	N/A	DWS Contrast?	N/A
			N/A	Landing Slope (%)	N/A	N/A	DWS Length (in)	N/A
			N/A	Landing X Slope (%)	N/A	N/A	DWS Full Width?	N/A
			N/A	Landing Curb? (Y/N)	N/A	N/A	DWS Offset (in)	N/A
			N/A	Shared Landing?	N/A			
			N/A	Gutter Ponding?	N/A	N/A	Gutter Slope (%)	N/A
			N/A	Gutter Lip Ht (in)	N/A	N/A	Gutter X Slope (%)	N/A

Total Cost: \$ 3200.00
