Access Compliance Report Public Rights-of-Way (Curb Ramps)

Intersection ID: 30561 Main Street: BUBBLING BRANCH LN **Cross Street: CIRCLEGREEN DR** Location: Ε **ADA ID: FC9DE9EDA45F** Ramp Type: PerpDiag Initial Pass/Fail: Fail **Overall Compliance: No Severity Score:** 25

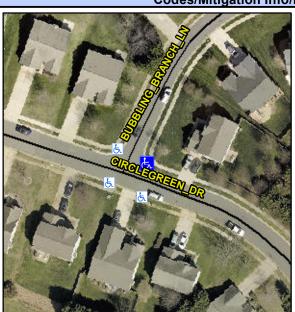
Field Measurements/Component Compilance						
	Compl	liance Description	Data	Compliance Description		Data
	N/A	Ramp Length (in)	49.0	Yes	Ramp Slope (%)	6.5
	Yes	Ramp Width (in)	48.0	No	Ramp XSlope (%)	8.5
	N/A	Flare Type LT	N/A	N/A	Flare Type RT	N/A
	N/A	Flare Slope LT (%)	N/A	N/A	Flare Slope RT (%)	N/A
	N/A	Flare Traversable LT?	N/A	N/A	Flare Traversable RT?	N/A
	N/A	Landing Length (in)	N/A	N/A	DWS Provided?	N/A
	N/A	Landing Width (in)	N/A	N/A	DWS Contrast?	N/A
	N/A	Landing Slope (%)	N/A	N/A	DWS Length (in)	N/A
	N/A	Landing X Slope (%)	N/A	N/A	DWS Full Width?	N/A
	N/A	Landing Curb? (Y/N)	N/A	N/A	DWS Offset (in)	N/A
	N/A	Shared Landing?	N/A			
	N/A	Gutter Ponding?	N/A	N/A	Gutter Slope (%)	N/A
	N/A	Gutter Lip Ht (in)	N/A	N/A	Gutter X Slope (%)	N/A
	N/A	Painted X Walk1?	No	N/A	Painted X Walk2?	No
		X Walk 1 Direction	To NW		X Walk 2 Direction	To SW
	N/A	X Walk 1 Width (in)	N/A	N/A	X Walk 2 Width (in)	N/A
		X Walk 1 Slope (%)	6.3		X Walk 2 Slope (%)	1.2

X Walk 1 X Slope (%)	0.1		X Walk 2 X Slope (%)	6.7
	N/A	Ramp inside XWalk1?	N/A	N/A	Ramp inside XWalk2?	N/A
		Road Slope (%)	7.8	N/A	Clear Space?	N/A
		Road X Slope (%)	6.3	N/A	Clear Space to XWalk (in)	N/A
	N/A	Any Obstructions?	N/A	N/A	Storm Grate/Utility Hazard?	N/A
		Obstruction Type			Storm Grate/Utility Type	
			N/A			N/A
				Yes	Surface Condition? (G/P)	Good

Possible Solutions: Remove & Replace Curb Ramp With Two New Directional Ramps or Equivalent. Surveyor Notes: N/A PROW/ADA: Not Found, R304.5.3
