Access Compliance Report

Public Rights-of-Way

(Curb Ramps)

Intersection ID: 14455	Main Street: EAST_BV	Cross Street: WINTHROP_AV	Location: NE
ADA ID: FCA83A92E34C	Ramp Type: BlendTrans1	Initial Pass/Fail: Fail	Overall Compliance: No
Codes/Mitigation Info/Possible Solution		Field Measurements/Component Compliance	
Severity Score: 1.25

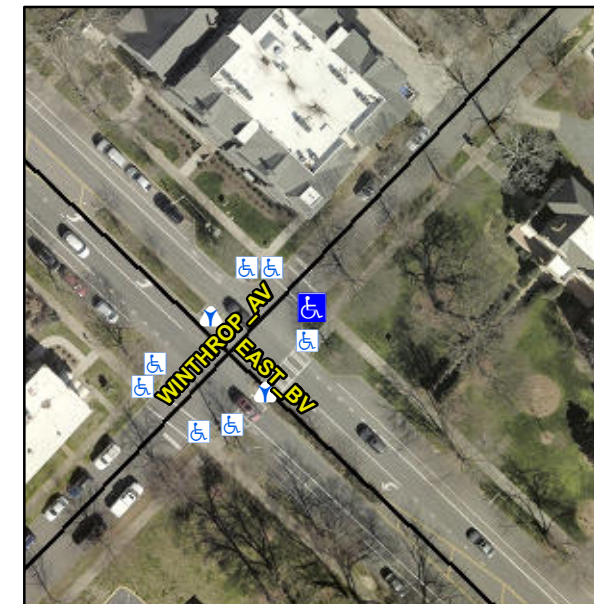
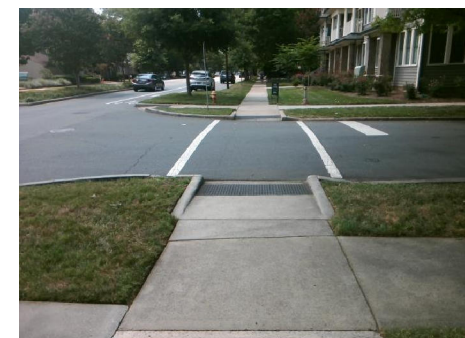
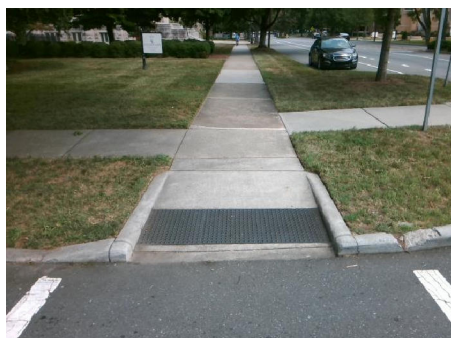
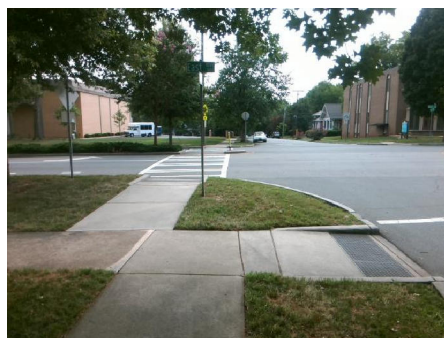
Not Found, R304.5.3

Compliance	Description	Data	Compliance	Description	Data
N/A	Ramp Length (in)	67.0	Yes	BlendTrans Slope (%)	4.4
Yes	Ramp Width (in)	72.0	No	BlendTrans XSlope (%)	3.0
N/A	Flare Type LT	N/A	N/A	Flare Type RT	N/A
N/A	Flare Slope LT (%)	N/A	N/A	Flare Slope RT (%)	N/A
N/A	Flare Traversable LT?	N/A	N/A	Flare Traversable RT?	N/A
N/A	Landing Length (in)	N/A	N/A	DWS Provided?	N/A
N/A	Landing Width (in)	N/A	N/A	DWS Contrast?	N/A
N/A	Landing Slope (%)	N/A	N/A	DWS Length (in)	N/A
N/A	Landing X Slope (%)	N/A	N/A	DWS Full Width?	N/A
N/A	Landing Curb? (Y/N)	N/A	N/A	DWS Offset (in)	N/A
N/A	Shared Landing?	N/A			
N/A	Gutter Ponding?	N/A	N/A	Gutter Slope (%)	N/A
N/A	Gutter Lip Ht (in)	N/A	N/A	Gutter X Slope (%)	N/A
N/A	Painted X Walk1?	Yes	N/A	Painted X Walk2?	N/A
	X Walk 1 Direction	To NW		X Walk 2 Direction	N/A
	X Walk 1 Width (in)	110.0		X Walk 2 Width (in)	N/A
	X Walk 1 Slope (%)	6.2		X Walk 2 Slope (%)	N/A
	X Walk 1 X Slope (%)	2.0		X Walk 2 X Slope (%)	N/A

N/A	Ramp inside XWalk1?	Yes	N/A	Ramp inside XWalk2?	N/A
	Road Slope (%)	2.0		Clear Space?	N/A
	Road X Slope (%)	6.2	N/A	Clear Space to XWalk (in)	N/A
N/A	Any Obstructions?	N/A	N/A	Storm Grate/Utility Hazard?	N/A
	Obstruction Type			Storm Grate/Utility Type	
		N/A			N/A
			Yes	Surface Condition? (G/P)	Good
			No	Curb Slope (%)	7.0

Possible Solutions:

Remove & Replace Curb Ramp With Two New Directional Ramps or Equivalent.
