# Access Compliance Report

## Public Rights-of-Way

### (Curb Ramps)

Intersection ID: 17274	Main Street: MONROE_RD	Cross Street: VISTA_DR	Location: NE
ADA ID: FCAA8EA28F46	Ramp Type: Directional1	Initial Pass/Fail: Fail	Overall Compliance: No
Severity Score: 12.5			
Codes/Mitigation Info/Possible Solution		Field Measurements/Component Compliance

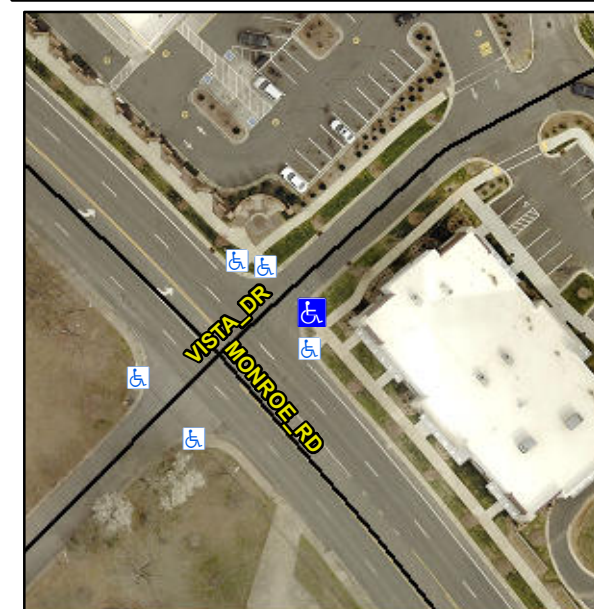
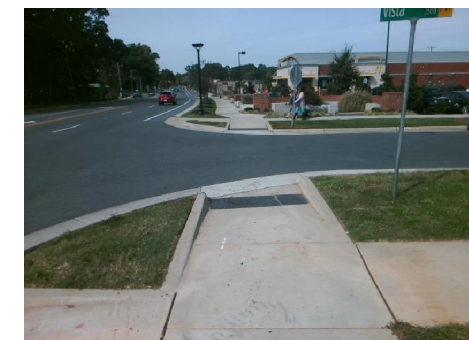
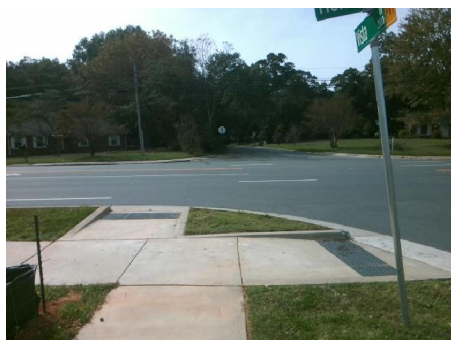
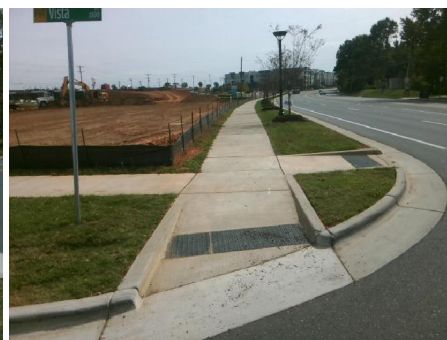
Compliance	Description	Data	Compliance	Description	Data
N/A	Ramp Length (in)	78.0	N/A	Grade Break?	N/A
Yes	Ramp Width (in)	69.0	N/A	Grade Break Slope (%)	0.0
No	Ramp Slope (%)	9.0	N/A	Grade Break XSlope (%)	0.0
Yes	Ramp XSlope (%)	1.1			
N/A	Flare Type LT	N/A	N/A	Flare Type RT	N/A
N/A	Flare Slope LT (%)	N/A	N/A	Flare Slope RT (%)	0.0
N/A	Flare Traversable LT?	N/A	N/A	Flare Traversable RT?	N/A
N/A	Landing Length (in)	0.0	N/A	DWS Provided?	N/A
N/A	Landing Width (in)	0.0	N/A	DWS Contrast?	N/A
N/A	Landing Slope (%)	0.0	N/A	DWS Length (in)	N/A
N/A	Landing X Slope (%)	0.0	N/A	DWS Full Width?	N/A
N/A	Landing Curb? (Y/N)	N/A	N/A	DWS Offset LT (in)	N/A
N/A	Shared Landing?	N/A	N/A	DWS Offset RT (in)	N/A
N/A	Gutter Ponding?	0.0	N/A	Gutter Slope (%)	N/A
N/A	Gutter Lip Ht (in)	0.0	N/A	Gutter X Slope (%)	N/A
N/A	Painted X Walk1?	No		Road Slope (%)	0.8
	X Walk 1 Direction	To NW		Road X Slope (%)	0.8
	X Walk 1 Width (in)	N/A		Clear Space?	N/A

X Walk 1 Slope (%)	0.8	N/A	Clear Space to XWalk (in)	N/A
	X Walk 1 X Slope (%)	0.8	N/A	Storm Grate/Utility Hazard?	N/A
N/A	Ramp inside XWalk1?	N/A		Storm Grate/Utility Type	
N/A	Any Obstructions?	N/A			N/A
	Obstruction Type		Yes	Surface Condition? (G/P)	Good
			N/A	Curb Slope (%)	2.8

**Remove & Replace Entire Ramp.**

**R304.2.2**

\$ 1600.00
