Access Compliance Report

Public Rights-of-Way

(Curb Ramps)

Intersection ID: 48956	Main Street: JOSHUA_CAIN_RD	Cross Street: DAVID_JENNINGS_AV	Location: NE
ADA ID: FCAFF43DD471	Ramp Type: Perp	Initial Pass/Fail: Fail	Overall Compliance: No
Severity Score: 8.75			
Codes/Mitigation Info/Possible Solution		Field Measurements/Component Compliance

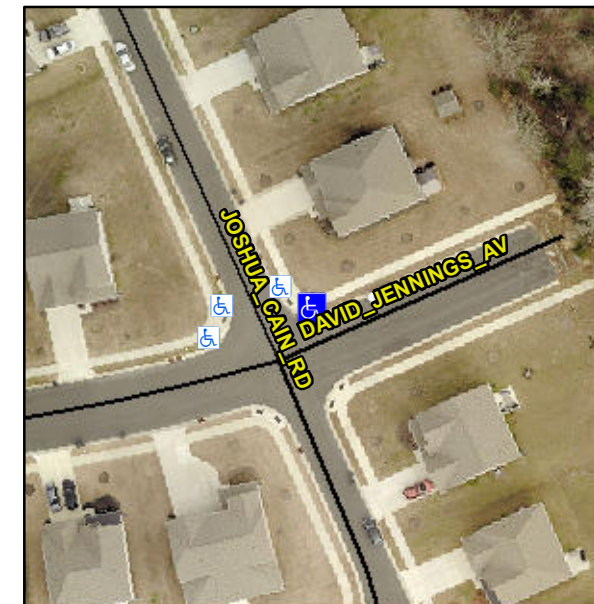
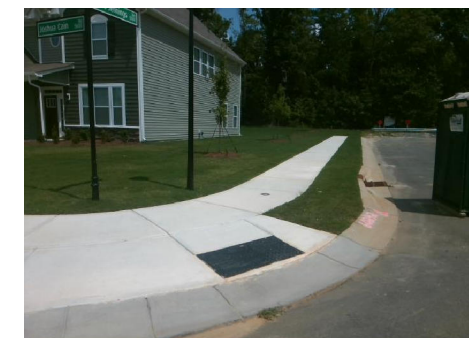
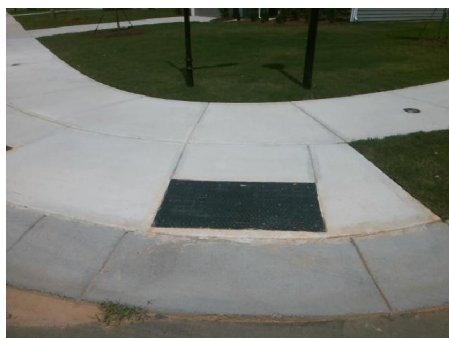
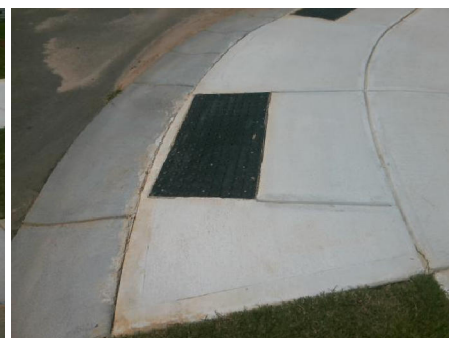
Not Found, R304.5.1

Compliance	Description	Data	Compliance	Description	Data
N/A	Ramp Length (in)	53.0	Yes	Ramp Slope (%)	6.4
No	Ramp Width (in)	47.0	Yes	Ramp XSlope (%)	1.4
N/A	Flare Type LT	N/A	N/A	Flare Type RT	N/A
N/A	Flare Slope LT (%)	N/A	N/A	Flare Slope RT (%)	N/A
N/A	Flare Traversable LT?	N/A	N/A	Flare Traversable RT?	N/A
N/A	Landing Length (in)	N/A	N/A	DWS Provided?	N/A
N/A	Landing Width (in)	N/A	N/A	DWS Contrast?	N/A
N/A	Landing Slope (%)	N/A	N/A	DWS Length (in)	N/A
N/A	Landing X Slope (%)	N/A	N/A	DWS Full Width?	N/A
N/A	Landing Curb? (Y/N)	N/A	N/A	DWS Offset (in)	N/A
N/A	Shared Landing?	N/A			
N/A	Gutter Ponding?	N/A	N/A	Gutter Slope (%)	N/A
N/A	Gutter Lip Ht (in)	1.0	N/A	Gutter X Slope (%)	N/A
N/A	Painted X Walk1?	No	N/A	Painted X Walk2?	N/A
	X Walk 1 Direction	To S		X Walk 2 Direction	N/A
N/A	X Walk 1 Width (in)	N/A	N/A	X Walk 2 Width (in)	N/A
	X Walk 1 Slope (%)	3.0		X Walk 2 Slope (%)	N/A
	X Walk 1 X Slope (%)	2.2		X Walk 2 X Slope (%)	N/A

N/A	Ramp inside XWalk1?	N/A	N/A	Ramp inside XWalk2?	N/A
	Road Slope (%)	2.2	N/A	Clear Space?	N/A
	Road X Slope (%)	3.0	N/A	Clear Space to XWalk (in)	N/A
N/A	Any Obstructions?	N/A	N/A	Storm Grate/Utility Hazard?	N/A
	Obstruction Type			Storm Grate/Utility Type	
		N/A			N/A
			Yes	Surface Condition? (G/P)	Good

Possible Solutions:

Remove & Replace Entire Ramp.
