# Access Compliance Report

## Public Rights-of-Way

### (Curb Ramps)

Intersection ID: 18776	Main Street: SOUTH_BV	Cross Street: TYVOLA_RD	Location: SW
ADA ID: FCBF0220C7A3	Ramp Type: Perp	Initial Pass/Fail: Fail	Overall Compliance: No
		Severity Score: 12.5

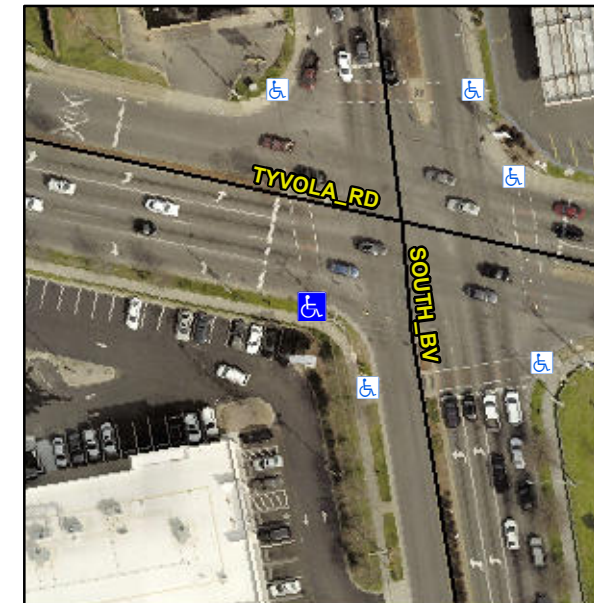
Compliance	Description	Data	Compliance	Description	Data
N/A	Ramp Length (in)	72.0	No	Ramp Slope (%)	9.8
Yes	Ramp Width (in)	48.0	Yes	Ramp XSlope (%)	0.8
N/A	Flare Type LT	N/A	N/A	Flare Type RT	N/A
N/A	Flare Slope LT (%)	N/A	N/A	Flare Slope RT (%)	N/A
N/A	Flare Traversable LT?	N/A	N/A	Flare Traversable RT?	N/A
N/A	Landing Length (in)	N/A	N/A	DWS Provided?	N/A
N/A	Landing Width (in)	N/A	N/A	DWS Contrast?	N/A
N/A	Landing Slope (%)	N/A	N/A	DWS Length (in)	N/A
N/A	Landing X Slope (%)	N/A	N/A	DWS Full Width?	N/A
N/A	Landing Curb? (Y/N)	N/A	N/A	DWS Offset (in)	N/A
N/A	Shared Landing?	N/A			
N/A	Gutter Ponding?	N/A	N/A	Gutter Slope (%)	N/A
N/A	Gutter Lip Ht (in)	N/A	N/A	Gutter X Slope (%)	N/A
N/A	Painted X Walk1?	Yes	N/A	Painted X Walk2?	N/A
	X Walk 1 Direction	To N		X Walk 2 Direction	N/A
N/A	X Walk 1 Width (in)	120.0	N/A	X Walk 2 Width (in)	N/A
	X Walk 1 Slope (%)	2.0		X Walk 2 Slope (%)	N/A
	X Walk 1 X Slope (%)	0.2		X Walk 2 X Slope (%)	N/A

N/A	Ramp inside XWalk1?	Yes	N/A	Ramp inside XWalk2?	N/A
	Road Slope (%)	N/A	N/A	Clear Space?	N/A
	Road X Slope (%)	N/A	N/A	Clear Space to XWalk (in)	N/A
N/A	Any Obstructions?	N/A	N/A	Storm Grate/Utility Hazard?	N/A
	Obstruction Type			Storm Grate/Utility Type	
		N/A			N/A
		Yes		Surface Condition? (G/P)	Good

**Remove & Replace Entire Ramp.**

**R304.2.2**
