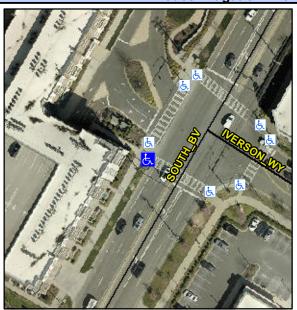
Intersection ID: 14754Main Street:SOUTH_BVCross Street:IVERSON_WYLocation:SWADA ID: FCC13B243CABRamp Type:PerpInitial Pass/Fail:FailOverall Compliance:NoSeverity Score:22.5

Field Measurements/Component Compliance							
Comp	liance Description	Data	Comp	liance	Description	Data	
N/A	Ramp Length (in)	72.0	No	Ram	Slope (%)	8.8	
No	Ramp Width (in)	47.0	No	Ram	XSlope (%)	2.8	
N/A	Flare Type LT	N/A	N/A	Flare	Type RT	N/A	
N/A	Flare Slope LT (%)	N/A	N/A	Flare	Slope RT (%)	N/A	
N/A	Flare Traversable LT?	N/A	N/A	Flare	Traversable RT?	N/A	
N/A	Landing Length (in)	N/A	N/A	DWS	Provided?	N/A	
N/A	Landing Width (in)	N/A	N/A	DWS	Contrast?	N/A	
N/A	Landing Slope (%)	N/A	N/A	DWS	Length (in)	N/A	
N/A	Landing X Slope (%)	N/A	N/A	DWS	Full Width?	N/A	
N/A	Landing Curb? (Y/N)	N/A	N/A	DWS	Offset (in)	N/A	
N/A	Shared Landing?	N/A					
N/A	Gutter Ponding?	N/A	N/A	Gutte	r Slope (%)	N/A	
N/A	Gutter Lip Ht (in)	N/A	N/A	Gutte	r X Slope (%)	N/A	
N/A	Painted X Walk1?	Yes	N/A	Paint	ed X Walk2?	N/A	
	X Walk 1 Direction	To SE		X Wa	lk 2 Direction	N/A	
N/A	X Walk 1 Width (in)	112.0	N/A	X Wa	lk 2 Width (in)	N/A

X Walk 1 Slope (%)	0.8		X Wa	lk 2 Slope (%)	N/A	
	X Walk 1 X Slope (%)	1.3		X Wa	lk 2 X Slope (%)	N/A	
N/A	Ramp inside XWalk1?	Yes	N/A	Ram	inside XWalk2?	N/A	
	Road Slope (%)	N/A	N/A	Clear	Space?	N/A	
	Road X Slope (%)	N/A	N/A	Clear	Space to XWalk (in)	N/A	
N/A	Any Obstructions?	N/A	N/A	Storn	n Grate/Utility Hazard?	N/A	
	Obstruction Type			Storn	n Grate/Utility Type		
		N/A				N/A	
			Yes	Surfa	ce Condition? (G/P)	Good	
	-!!

Possible Solutions:	9		
Remove & Replace Entire Ramp.			
	N		
	N		
	N		
	N		
	N		
Surveyor Notes:	N		
N/A	N		
	N		
	N		
	N		
PROW/ADA:	N		
R304.5.1, R304.2.2, R304.5.3	N		
	N		
	N		
	•

Total Cost:	\$ 1850.00
