# Access Compliance Report

## Public Rights-of-Way

### (Curb Ramps)

| Intersection ID: 49275 | Main Street: GATHERING_CT | Cross Street: REUNION_ST | Location: NW |

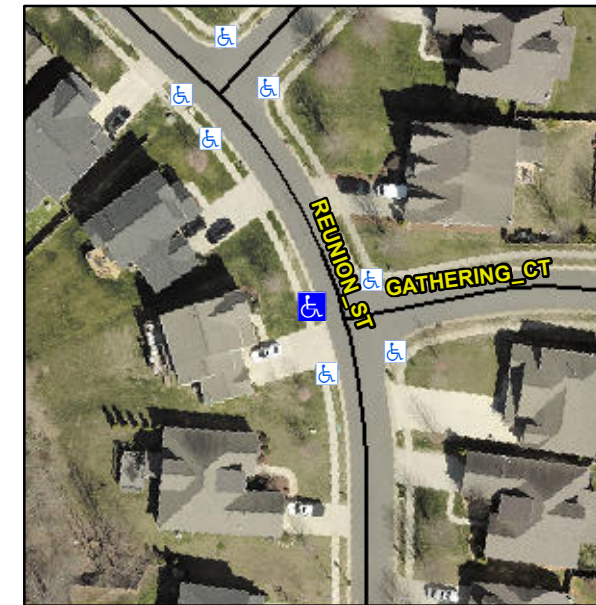
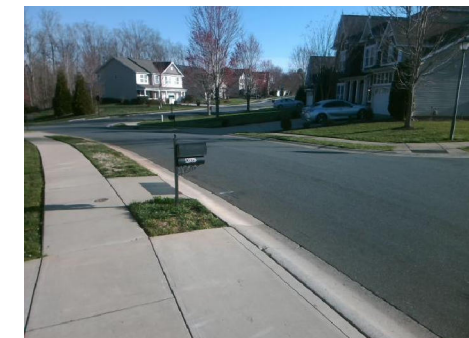
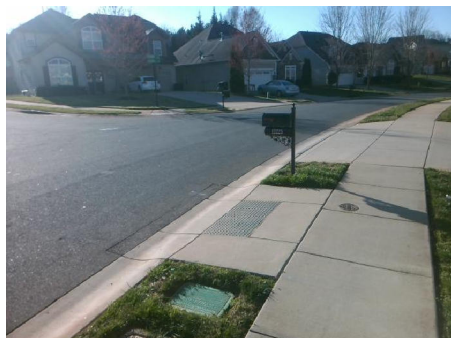
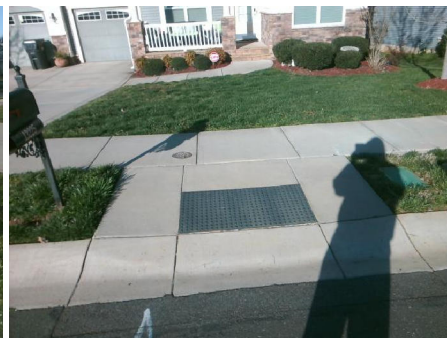
**Not Found, R304.5.1, R304.2.2, R304.5.3**

| Compliance | Description | Data | Compliance | Description | Data |
|---|---|---|---|---|---|
| N/A | Ramp Length (in) | 48.0 | No | Ramp Slope (%) | 10.0 |
| No | Ramp Width (in) | 47.3 | No | Ramp XSlope (%) | 2.4 |

**Remove & Replace Entire Ramp.**
